Technical Memorandum

Anacostia Tributary Streambank Erosion Study

Phase II-A

Upper Beaverdam and Indian Creek Subwatersheds

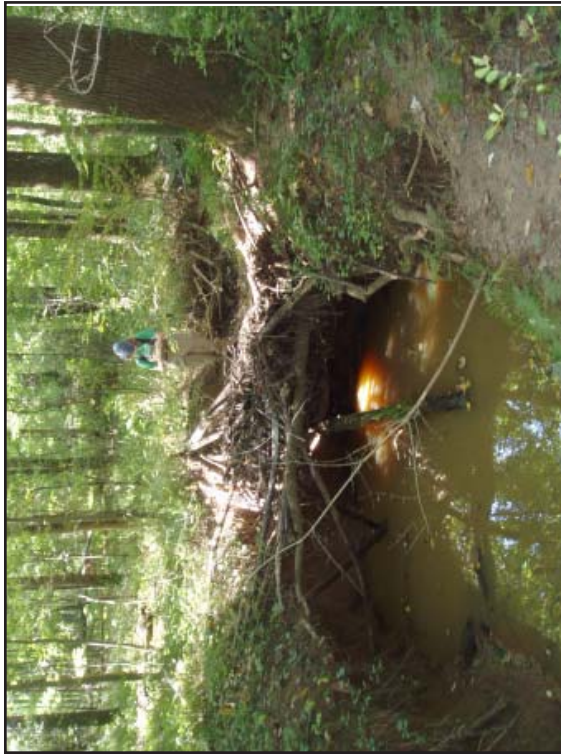
Figure 9: Location - Approx. 640 Feet Upstream of Goddard Tributary Confluence (Near X-1): Severe Streambank Erosion

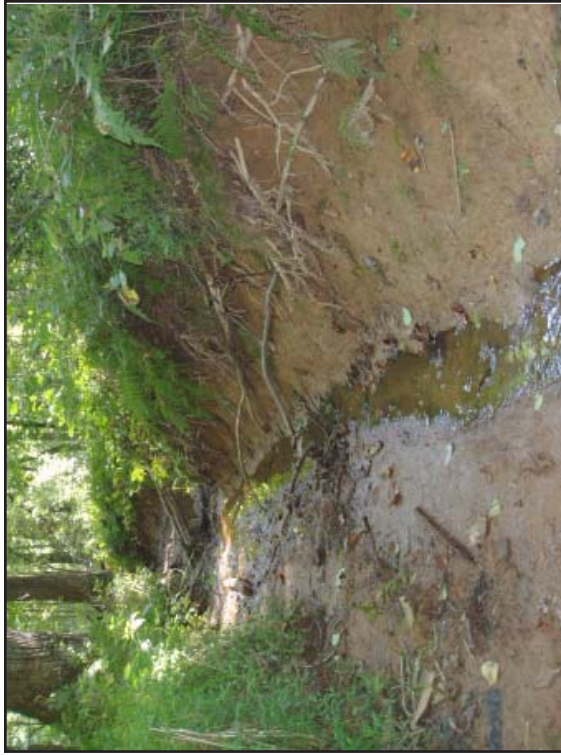
Figure 10: Location - Approx. 240 Feet Upstream of Goddard Tributary Confluence (X-2): Moderate Streambank Erosion

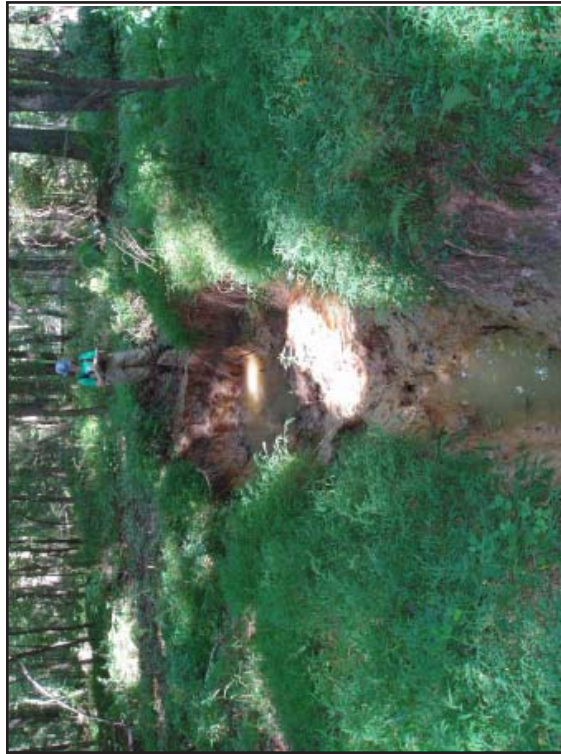
Figure 11: Location - Approx. 150 Feet Upstream of Goddard Tributary Confluence (Near X-3): Moderate Streambank Erosion

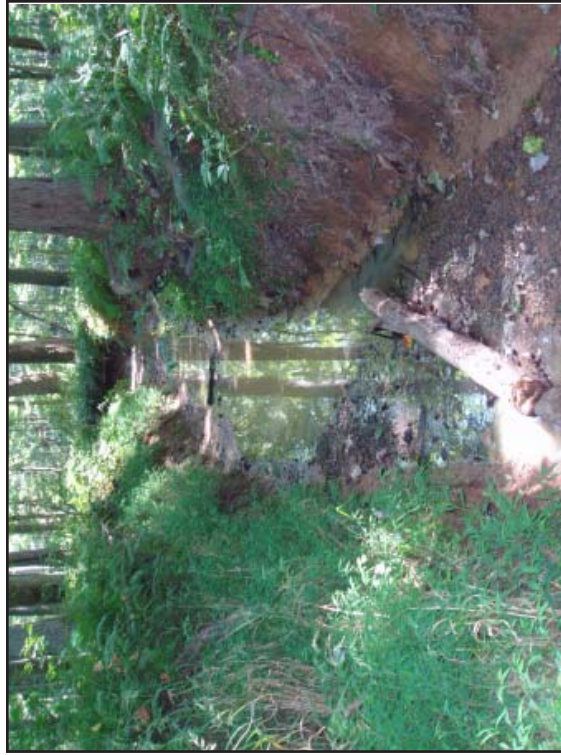
Figure 12: Location - Approx. 100 Feet Upstream of Goddard Tributary Confluence (X-3): Moderate Streambank Erosion

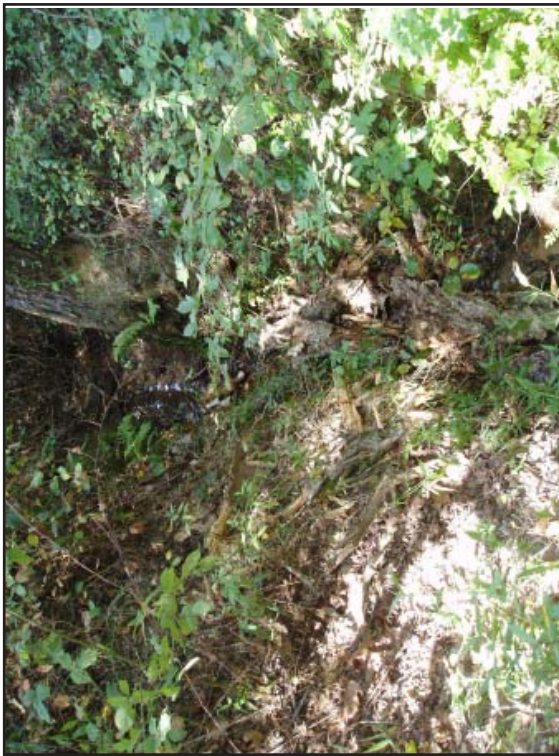
Location - Approx. 1,600 Feet Upstream of UBC Mainstem Confluence (X-1): Stable Streambank

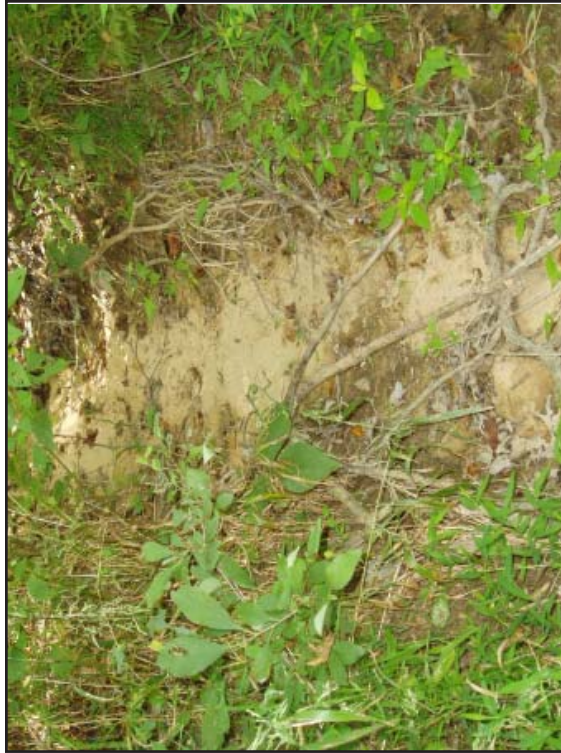
Figure 14: Location - Approx. 500 Feet Upstream of UBC Mainstem Confluence (X-3): Stable Streambank

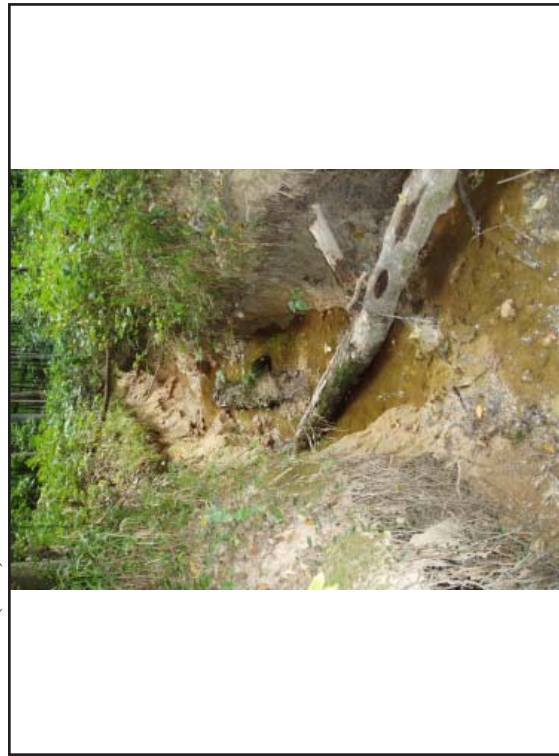
Figure 15: Location - Approx. 2,100 Feet Upstream of UBC Mainstem Confluence (X-1): Severe Streambank Erosion

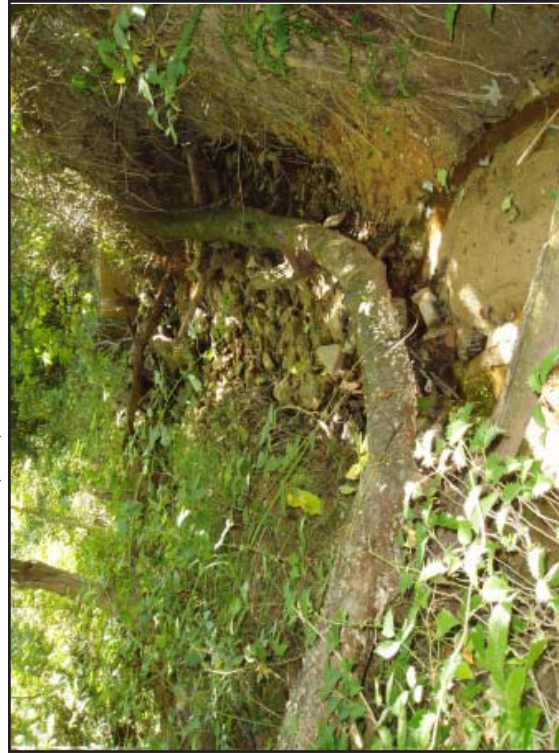
Figure 16: Location - Approx. 1,500 Feet Upstream of UBC Mainstem Confluence (X-2): Moderate Streambank Erosion

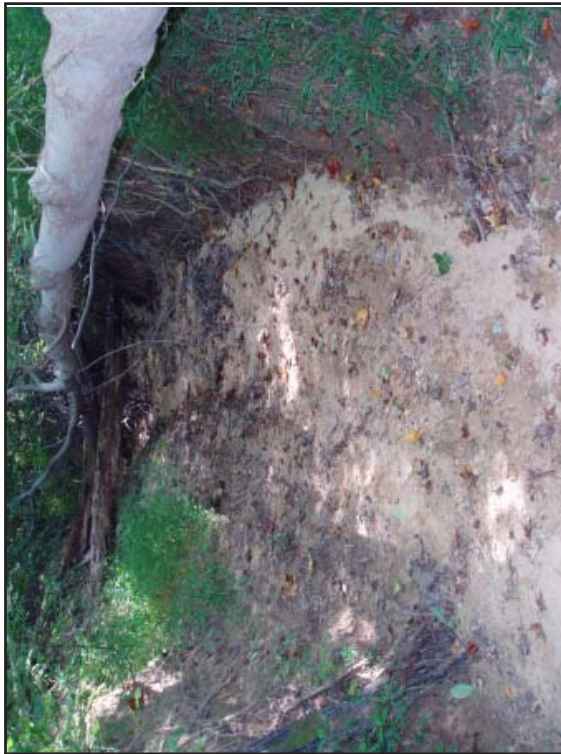
Figure 17: Location - Approx. 1,000 Feet Upstream of UBC Mainstem Confluence (X-3): Moderate Streambank Erosion

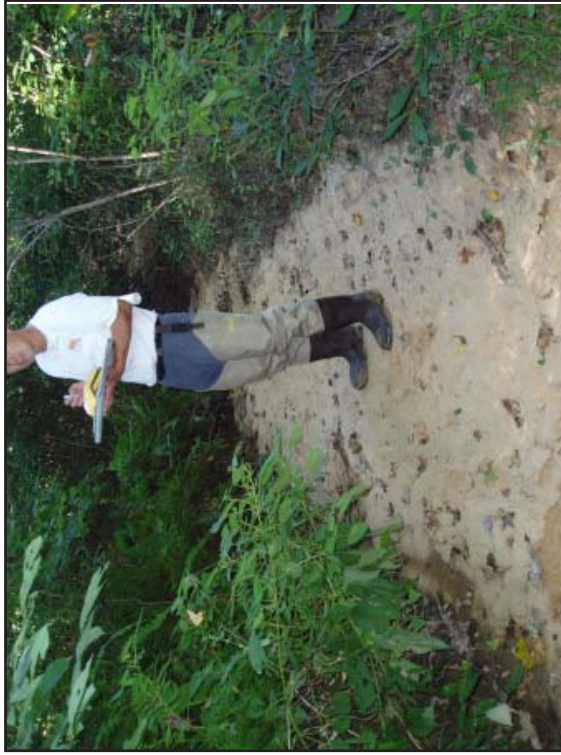
Figure 18: Location - Approx. 500 Feet Upstream of UBC Mainstem Confluence (X-4): Stable Streambank

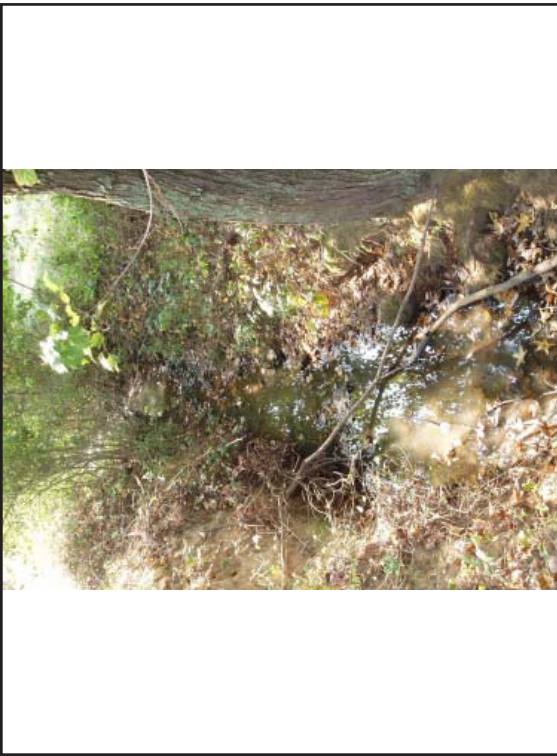
Figure 19: Location - Approx. 1,200 Feet Upstream of Powder Mill Road (X-1): Slight Streambank Erosion

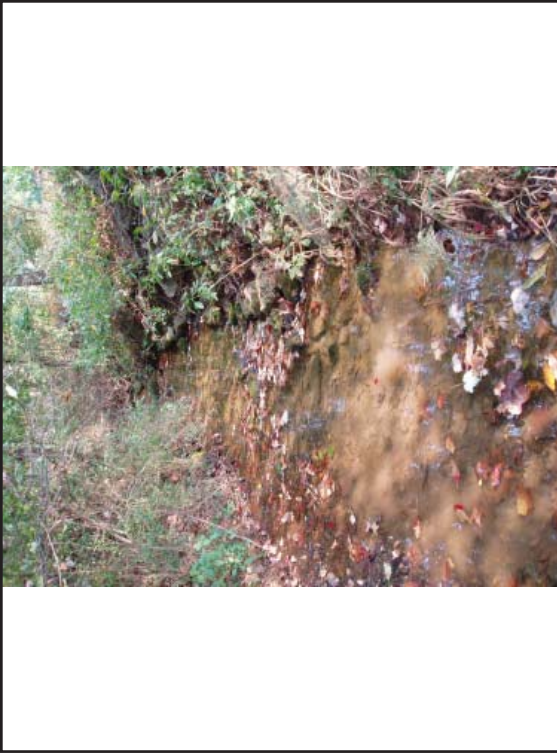
Figure 20: Location - Approx. 500 Feet Upstream of Powder Mill Road (Near X-3): Slight Streambank Erosion

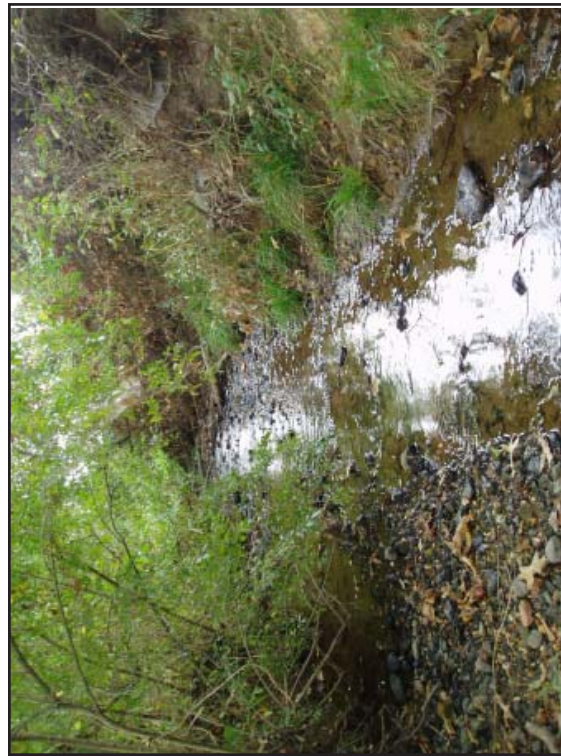
Figure 21: Location - Approx. 650 Feet Downstream of Powder Mill Road (X-5): Slight Streambank Erosion

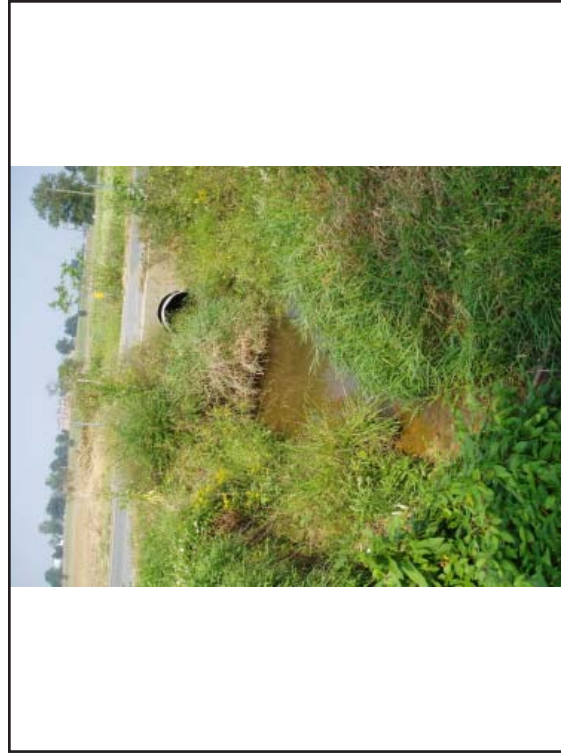
Figure 22: Location - Approx. 15 Feet Downstream of Beaverdam Road (X-7): Slight/Moderate Streambank Erosion

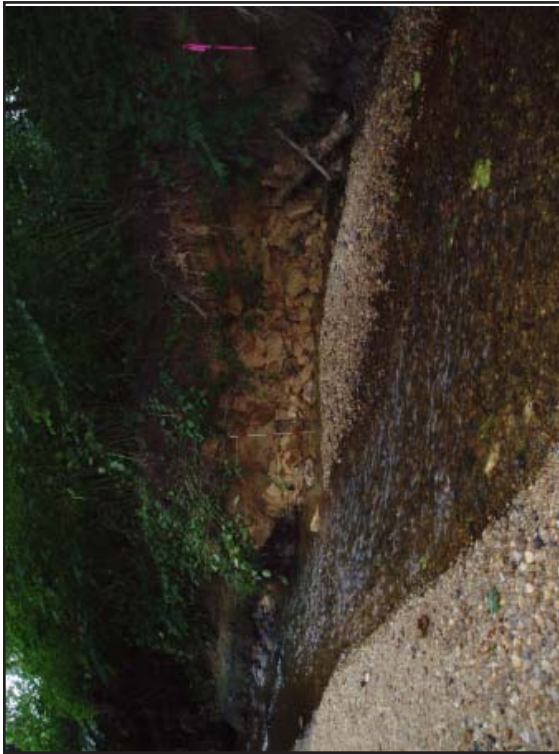
Figure 25: Location - Approx. 400 Feet Downstream of Powder Mill Road (Near X-1): Severe Streambank Erosion

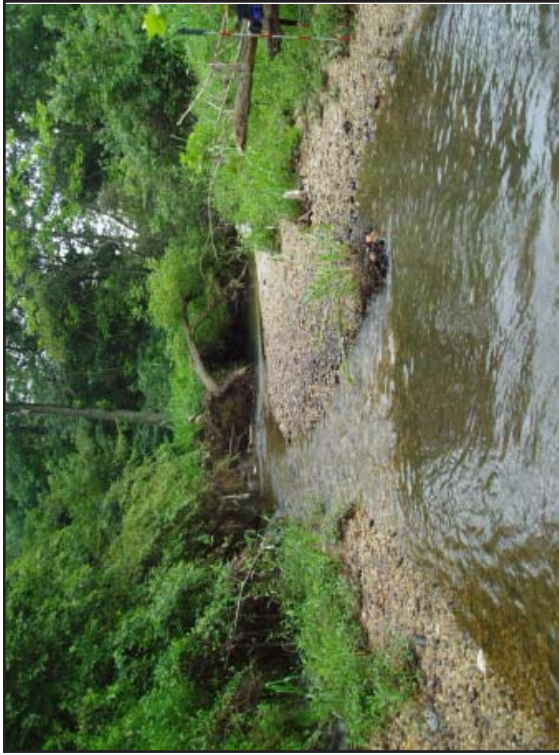
Figure 26: Location - Approx. 1,000 Feet Downstream of Powder Mill Road (X-2): Severe Streambank Erosion (Left Bank)

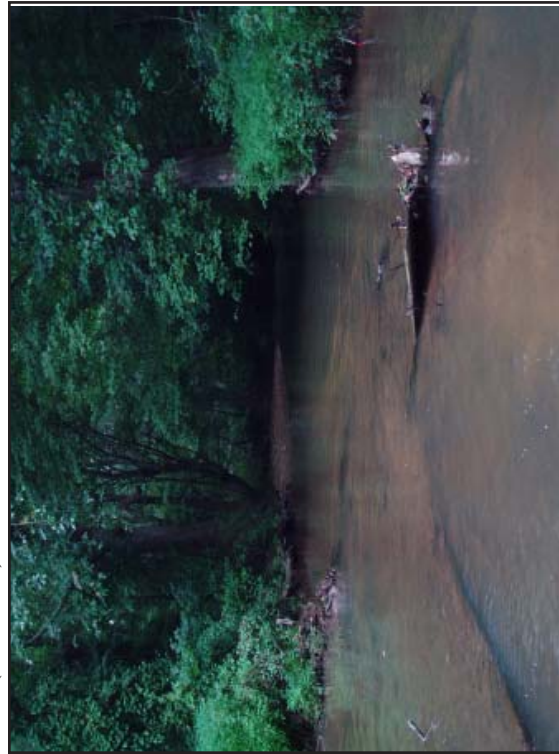
Figure 27: Location - Approx. 2,500 Feet Downstream of Powder Mill Road (X-5): Slight/Moderate Streambank Erosion

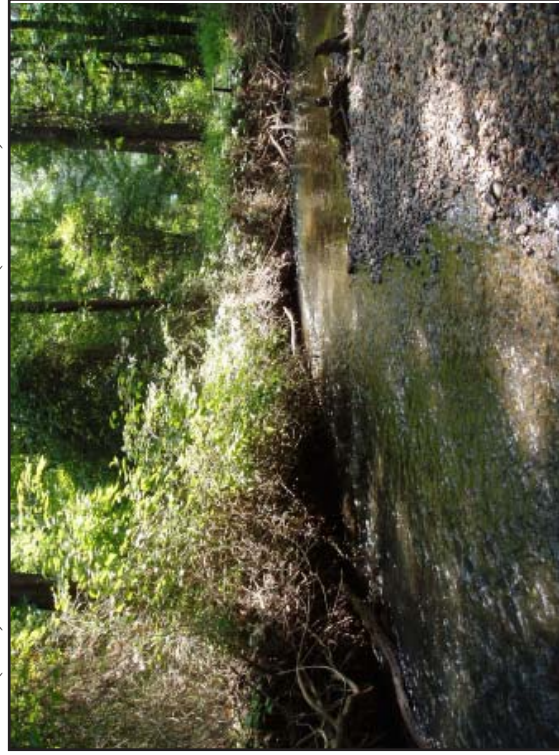
Figure 28: Location - Approx. 3,870 Feet Downstream of Powder Mill Road (X-8): Moderate/Severe Streambank Erosion

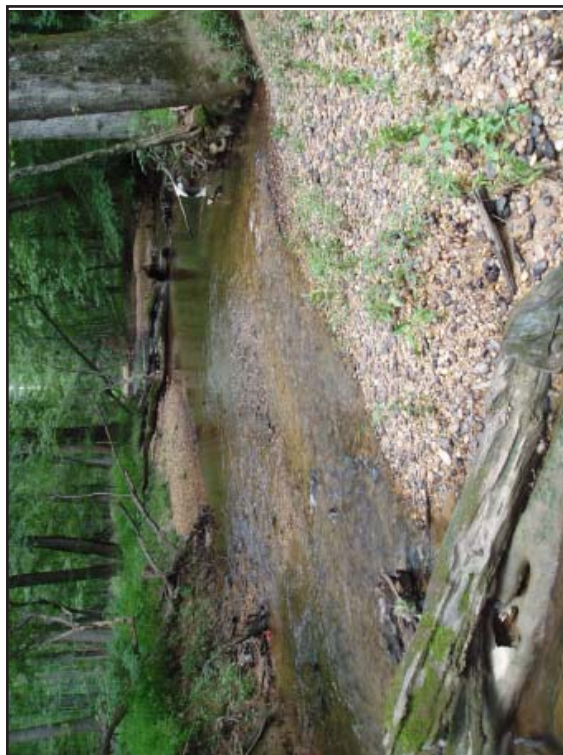
Figure 29: Location - Approx. 710 Feet Downstream of Sunnyside Avenue (X-10): Slight/Moderate Streambank Erosion

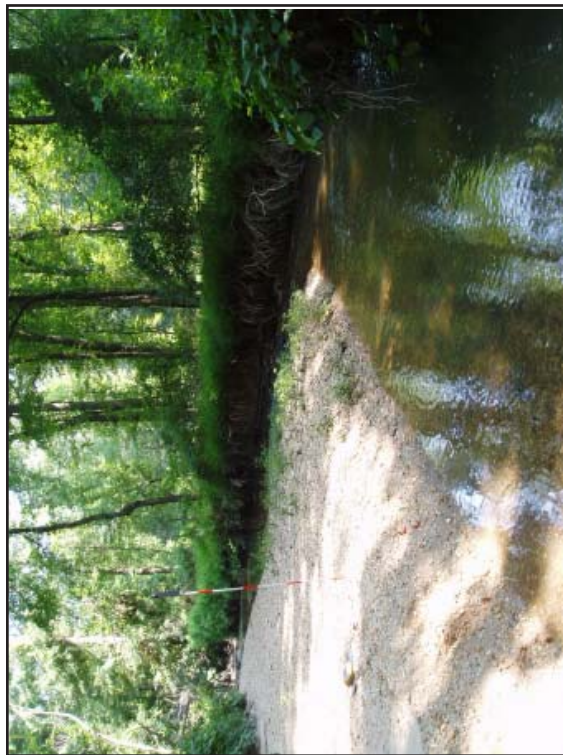
Figure 30: Location - Approx. 2,900 Feet Downstream of Powder Mill Road (X-13): Severe Streambank Erosion

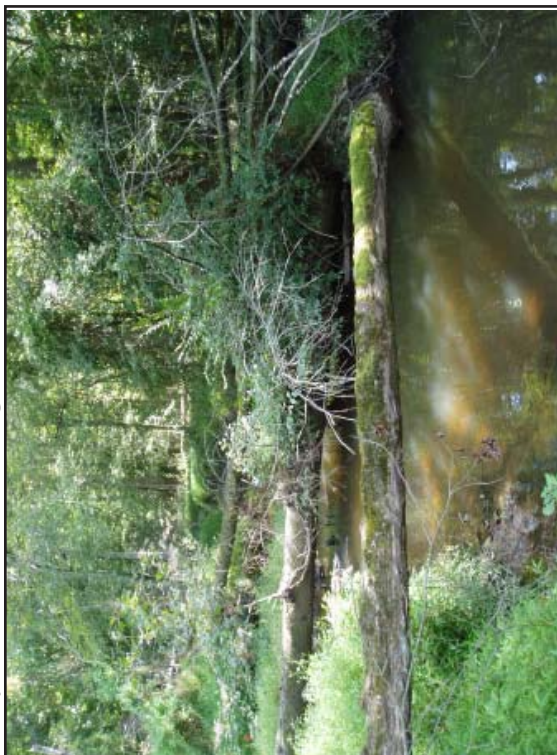
Figure 31: Location - Approx. 1,300 Feet Downstream of UBC Confluence (Near X-15): Moderate/Severe Streambank Erosion

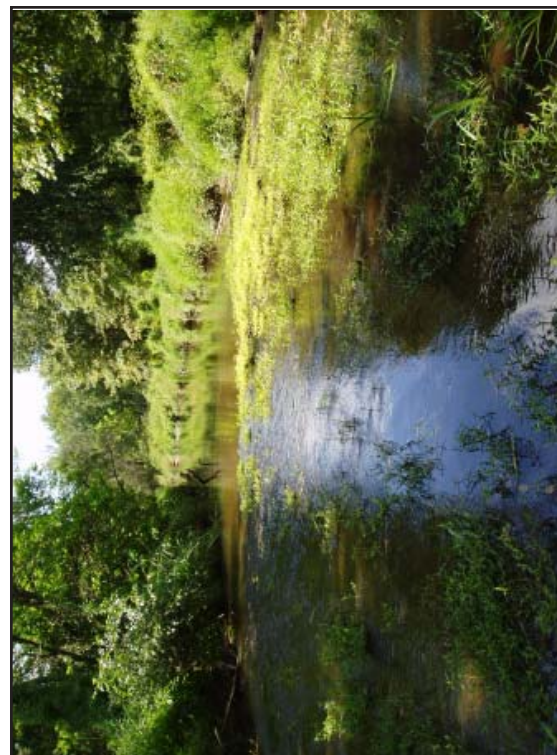
Figure 32: Location - Approx. 2,000 Feet Downstream of UBC Confluence (X-16): Slight/Moderate Streambank Erosion

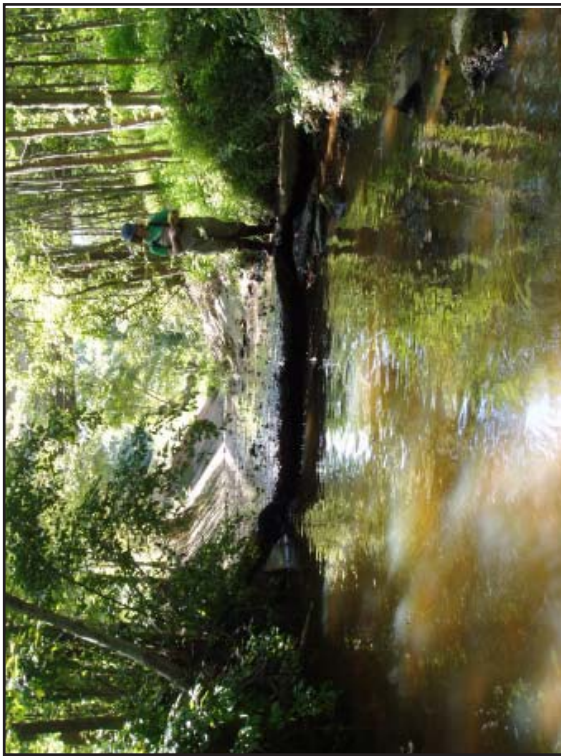
Figure 5: Location - Approx. 365 Feet Downstream of Baltimore/Washington Parkway (X-1): Slight/Moderate Streambank Erosion

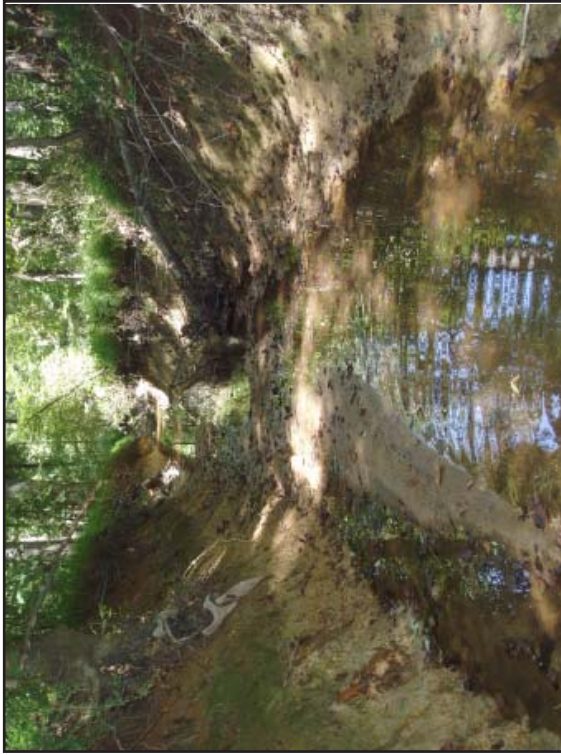
Figure 6: Location - Approx. 1,270 feet Downstream of Baltimore/Washington Parkway (X-3): Moderate Streambank Erosion

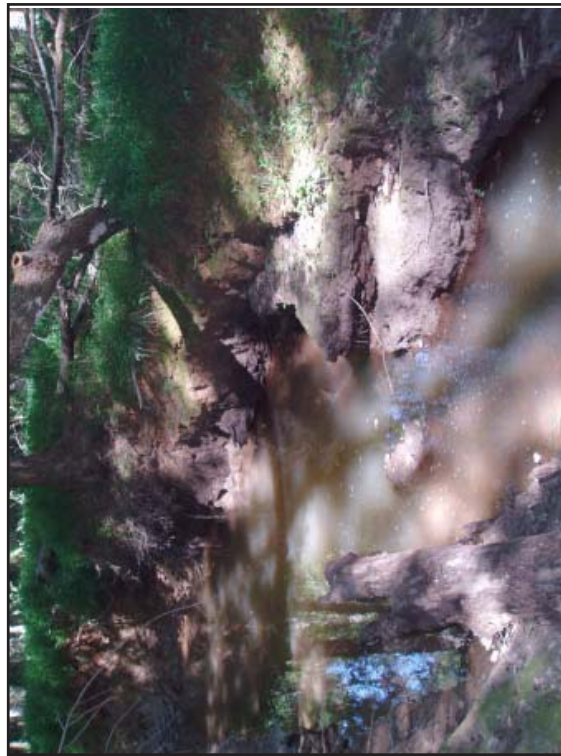
Figure 7: Location - Approx. 3,850 feet Downstream of Baltimore/Washington Parkway (X-8): Moderate/Severe Streambank Erosion

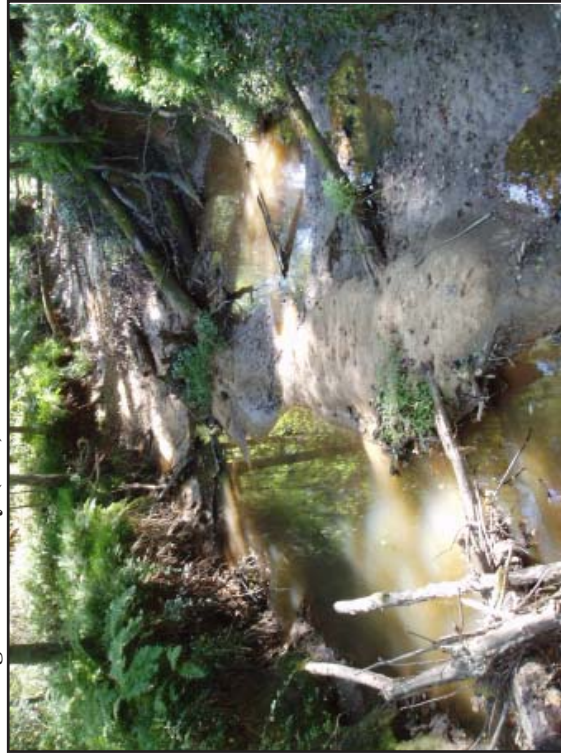
Figure 8: Location - Approx. 100 Feet Downstream of Baltimore/Washington Parkway (X-9): Moderate/Severe Streambank Erosion

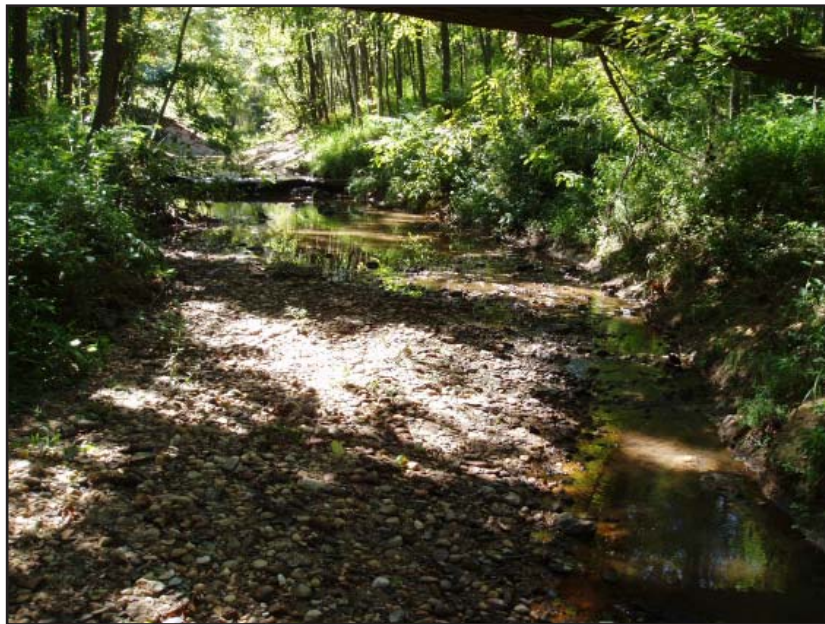
Figure 39: Location - Goddard Tributary Mainstem - Downstream of Baltimore/Washington Parkway: Excellent Stream Canopy Coverage

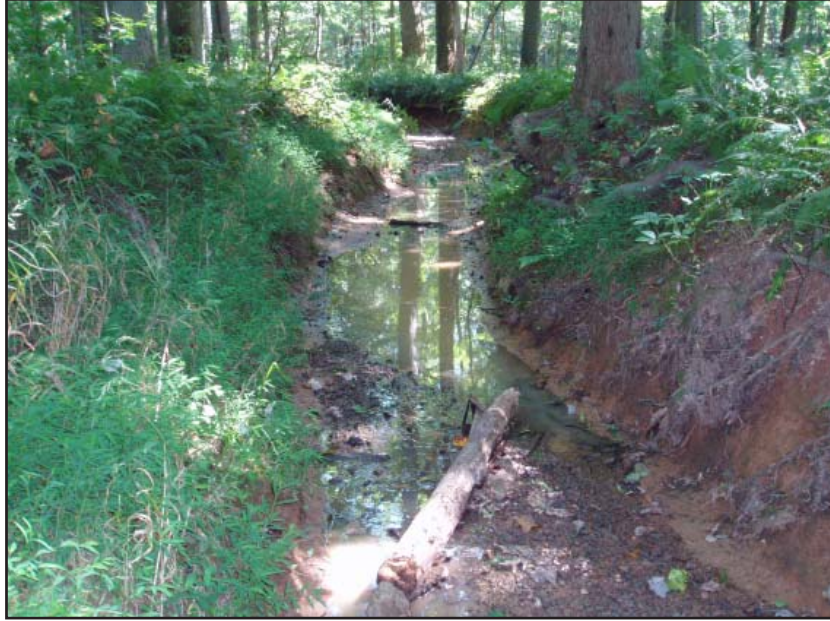
**Figure 40: Location - Greenbelt Forest Tributary Upstream of
Goddard Tributary Confluence: Excellent Stream Canopy Coverage**

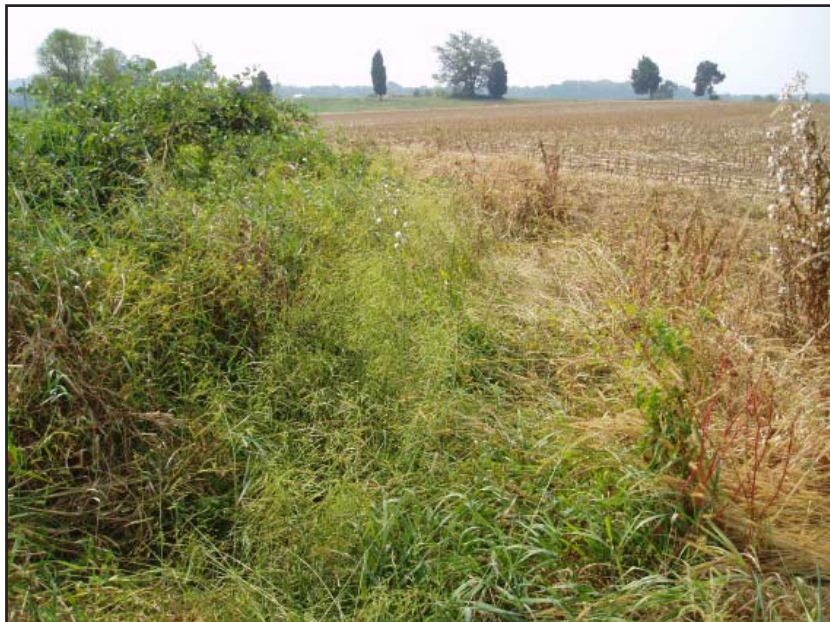
**Figure 41: Location - Poultry Road Tributary Downstream of Powder
Mill Road: Poor Stream Canopy Coverage**

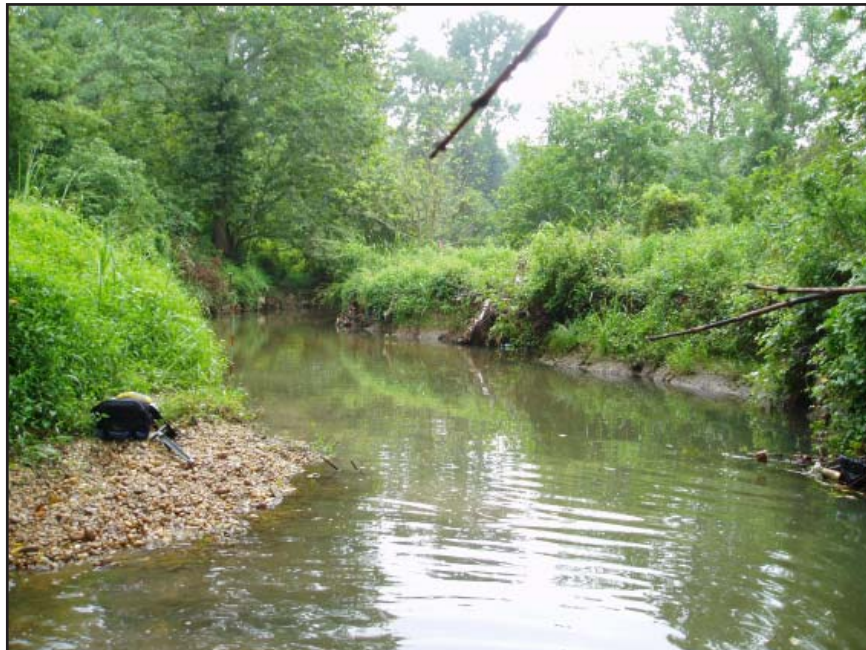
Figure 42: Location - Indian Creek Downstream of Powder Mill Road (X-3): Fair Stream Canopy Coverage

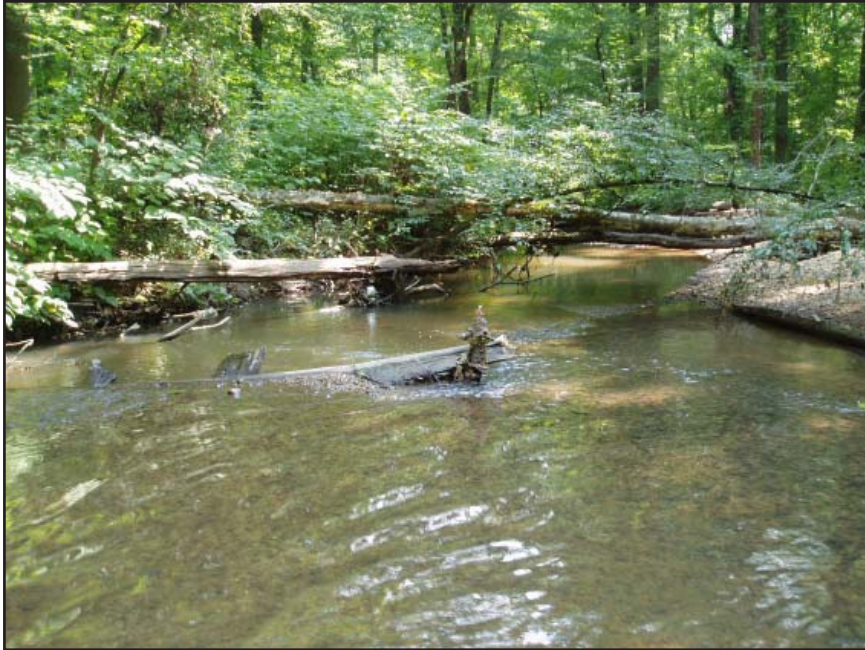
**Figure 43: Location - Indian Creek Downstream of Powder Mill Road
(X-6) : Excellent Stream Canopy Coverage**

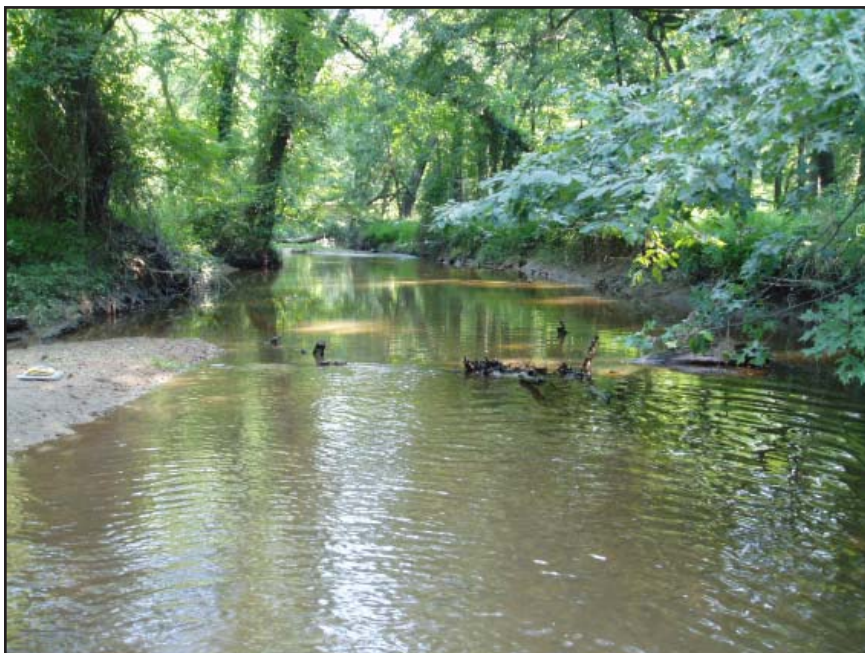
**Figure 44: Location - Indian Creek Downstream of Powder Mill Road
(X-14): Excellent Stream Canopy Coverage**

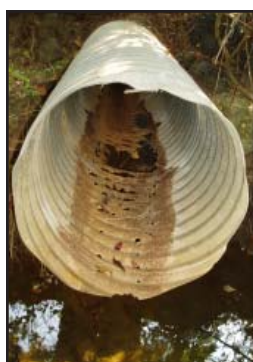
**UBC-11 - 24 inch
CMP stormdrain
outfall**

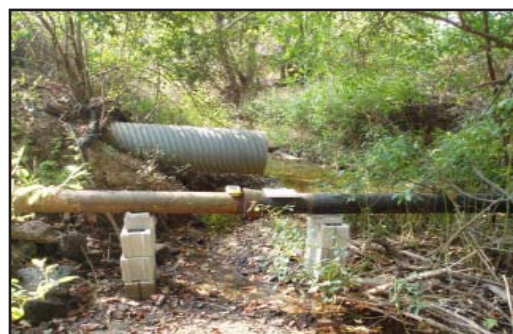
**UBC-11 - Ductile Iron Utility Line
Supported by Two Cinder Block Columns**

Road is currently being supported by two columns of cinder blocks. It is strongly recommended that a more permanent poured-in-place, concrete pier, replacement support system be installed by BARC as soon as possible.
