# **Pope Branch Subwatershed Restoration: 2002 Baseline Stream Assessment Study – Physical, Chemical, and Biological Conditions**

**Prepared for:  
District of Columbia  
Department of Health/  
Environmental Health Administration  
Watershed Protection Division**

**Prepared by:  
Department of Environmental Programs  
Metropolitan Washington Council of Governments**

**May 2003**

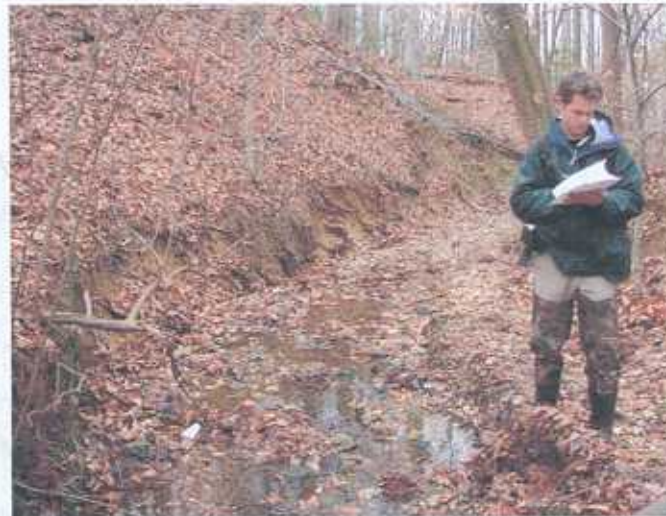
Figure 2 - Pope Branch - Upper Reach 'B' (X-6)

On December 18, 2001, COG staff performed a preliminary reconnaissance field survey of Pope Branch tributary in which a total open stream channel network length of 1.3 miles was identified (Figure 2). As part of this survey, a total of 30 permanent stream transects (spaced on average 200 to 300 feet apart) were established for the Rapid Stream Assessment Technique (RSAT) evaluation portion of the study (Figure 3). The entire open section of Pope Branch was RSAT surveyed. However, due to the severity of the drought which effectively dried up riffle and run habitat areas in the entire upper section (i.e., Upper Reach 'A' and 'B' from Fort Davis Drive to 35<sup>th</sup> Street), only two of the six RSAT Stream Evaluation Categories were scored (i.e., Bank Stability and Riparian Habitat) for this upper area.

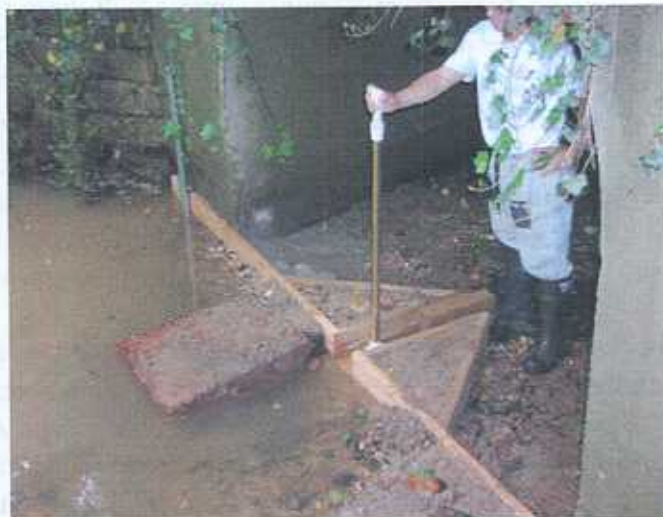
**Figure 4 - Lower Reach 'A' - Four-Inch High Broadcrested Weir At Minnesota Avenue**

For baseflow measurement, a temporary low-profile, four-inch high broadcrested wooden weir was installed on the upstream side of the Minnesota Avenue road culvert (RSAT transect X-26). The weir, which extended across the face of the culvert, effectively constricted baseflow through a 6.0-inch wide rectangular sluiceway (Figure 4). Baseflow discharges were measured in the sluiceway 20 times using a Marsh-McBirney Incorporated, model 2000 Flowmate flow probe. Measurements were taken from different dates (i.e., at least once a month between May 25<sup>th</sup> and August 10<sup>th</sup> and less frequently between August 10<sup>th</sup> and December 3<sup>rd</sup>). Again, the time was recorded for each discharge measurement that corresponded to the time that a stage height was recorded by the water level data logger. It should be noted that during the height of the drought (i.e., between June and September 2002) baseflow was dramatically reduced, with flow observed only from the Middle Reach on downstream.

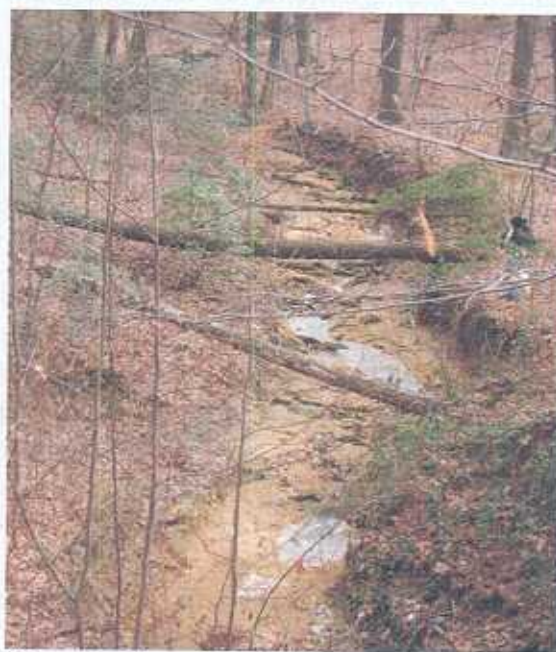
Figure 5 - Upper Reach 'A' - Recent Tree Falls

With the exception of Upper Reach 'A', Pope Branch appears to be actively eroding in its remaining open channel sections. Results from the channel stability portion of the study revealed that out of a total of 6,820 feet of RSAT-surveyed stream length, 520 linear feet, representing approximately 7.6 percent is experiencing severe bank erosion. Approximately 914 linear feet (13.0 percent) exhibited moderate/severe stream bank erosion conditions. An additional 780 linear feet (11.4 percent) exhibited moderate bank erosion conditions. Stream areas experiencing moderate, moderate/severe or severe stream bank erosion conditions were observed in both straight and meandering sections. As illustrated by Figure 5, these sections were frequently associated with numerous recent tree falls lying across the stream channel. Cross-sectional analysis results (Figure 5) indicated that the mean cross-sectional area of Upper Reach 'A' (9.2 ft<sup>2</sup>) is approximately four times smaller than the cross sectional areas of all four following downstream reaches: Upper Reach 'B' (42.3 ft<sup>2</sup>), Middle Reach (43.5 ft<sup>2</sup>), and Lower Reach 'A' (41.4 ft<sup>2</sup>), and 'B' (37.5 ft<sup>2</sup>).

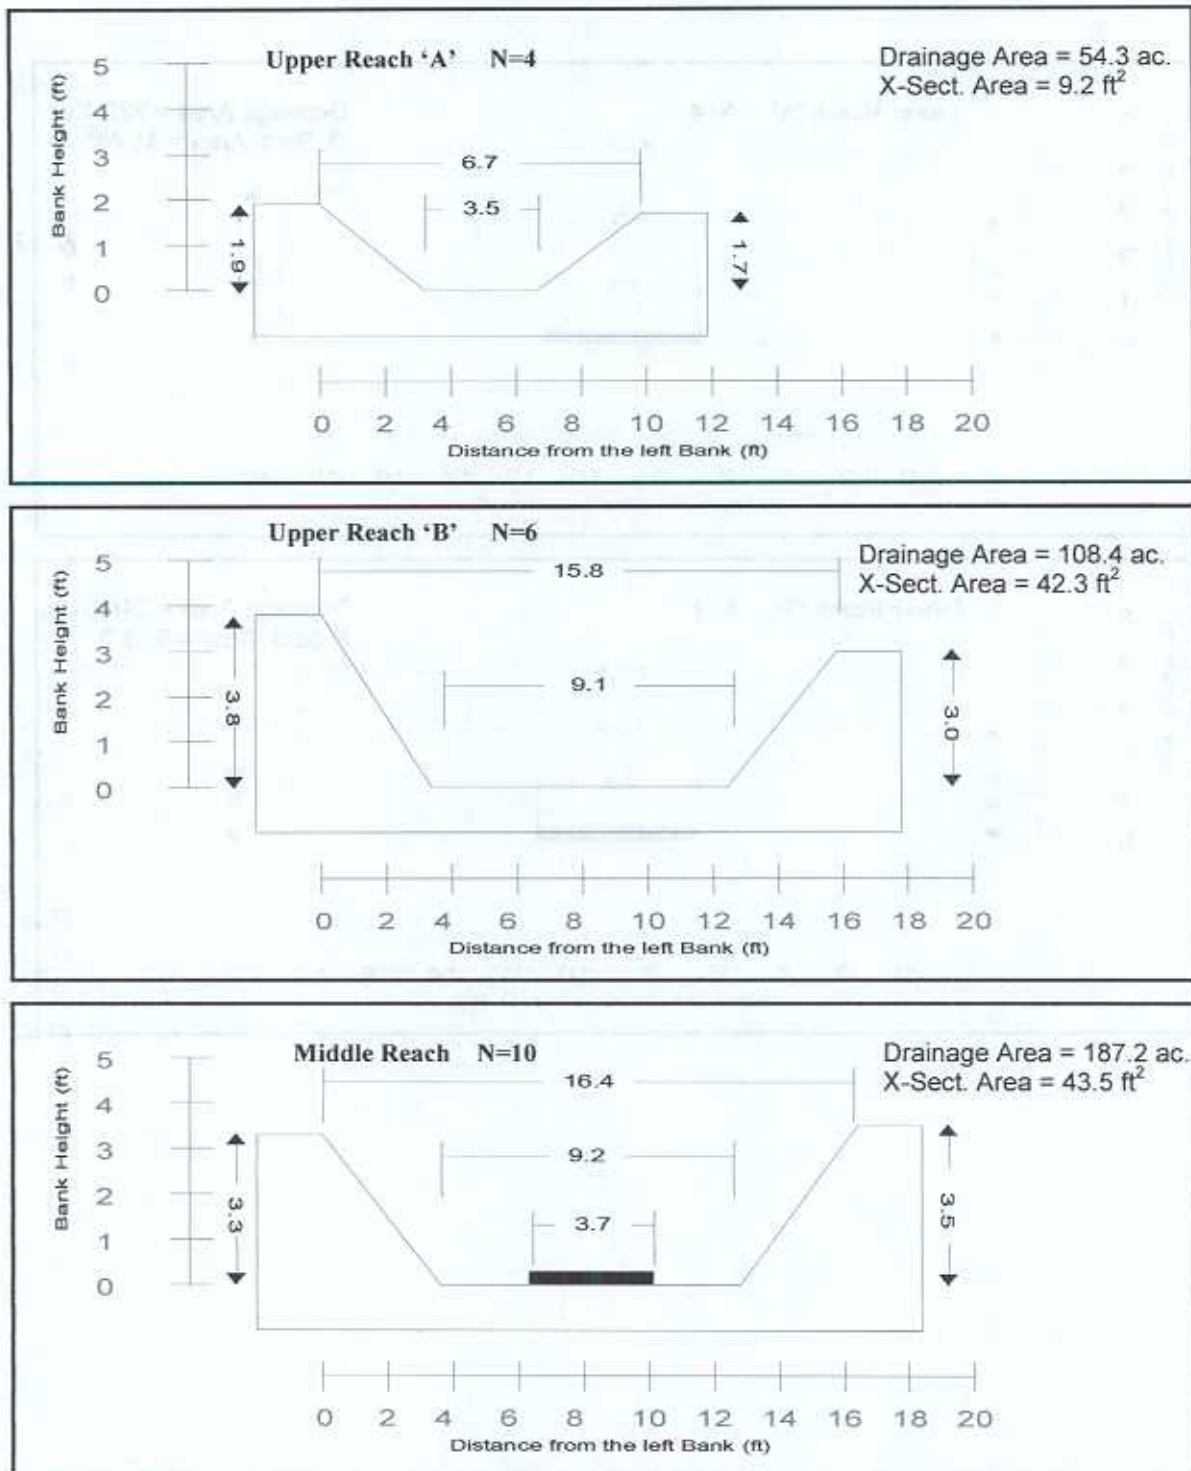
Figure 6 - Representative Channel Cross-Sections <sup>1</sup>

<sup>1</sup> Top channel width, bottom channel width and wetted perimeter area (heavy black line) depicted.  
 Note: Dry channel is indicated with absence of the heavy black line.

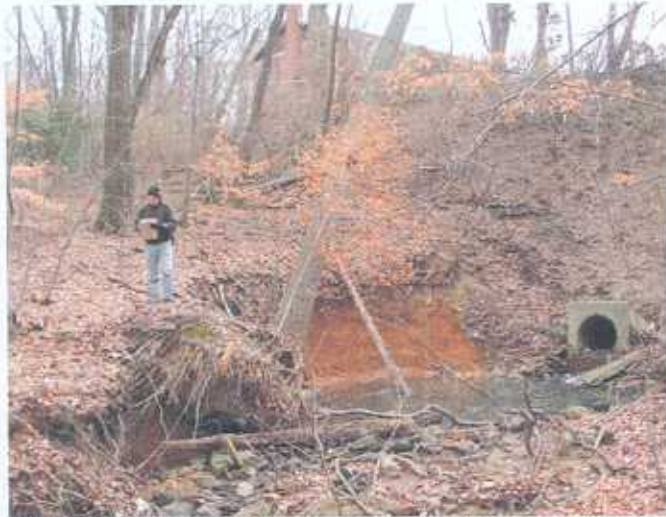
Figure 7 - Upper Reach 'B' - 33-Inch RCP Texas Avenue Storm Drain Outfall Area

Based on previous COG staff surveys of comparably-sized Coastal Plain and Piedmont streams in the Washington metropolitan area, the generally expected Pope Branch bank height and channel width ranges are on the order of one to three feet and 10 to 12 feet, respectively (Galli et al., 1999; Trieu et al., 1998; Galli et al., 1996b; Corish et al., 1996; Galli and Trieu, 1994). The preceding results confirm that decades of uncontrolled stormwater runoff, beginning at the upper most portion of Upper Reach 'B' (Figure 7) and extending all the way downstream to the piped entrance at Fairlawn Avenue has produced a Pope Branch stream channel, which is with respect to forested, reference stream conditions, markedly wider and more incised.

5. The six following storm drain system outfall locations are either in need of major repair and/or the installation of more effective velocity dissipation features: 'O' Street, Texas Avenue, 35<sup>th</sup> Street, 33<sup>rd</sup> Place, 34<sup>th</sup> Street and Branch Avenue.

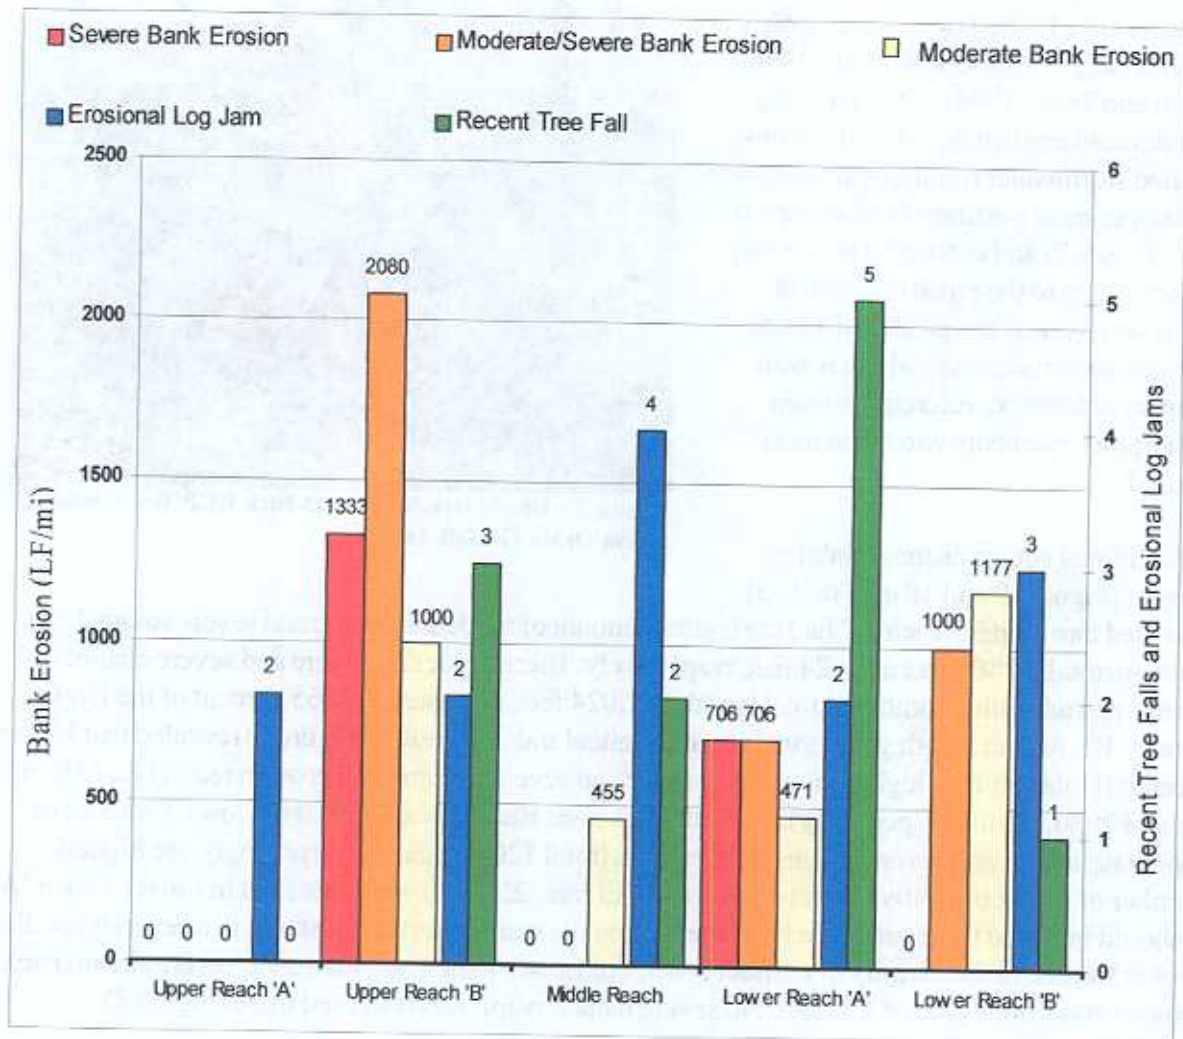
Figure 8 - Pope Branch Stream Channel Erosion-Related Conditions<sup>1</sup>

<sup>1</sup> Actual numbers appear above each bar for recent tree falls and erosional log jams. lf/mi. rate shown above each bar for severe and moderate stream bank erosion.

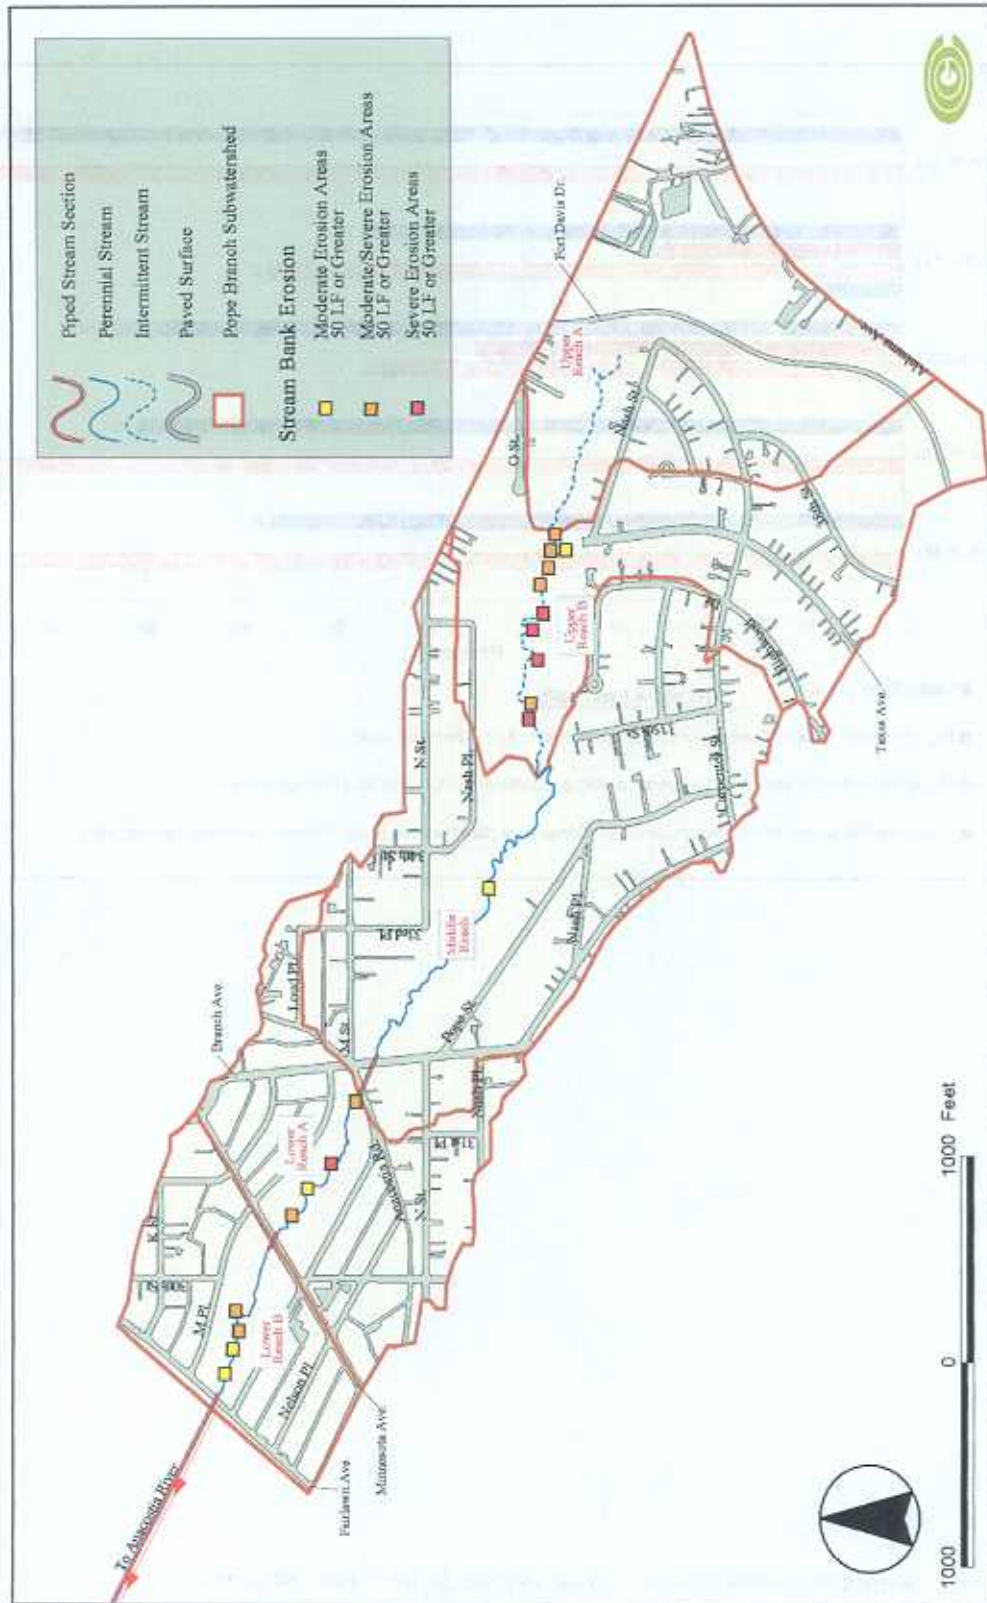
Figure 10 - Summary - Pope Branch Mean Stream Bank Stability and Relative Erodibility (%)<sup>1</sup>

Both stream bank and soil texture survey data were examined to provide a reconnaissance-level assessment of mean stream bank stability and relative erodibility of existing bank materials. As seen in Figure 10, mean stream bank stability ranged from a low of 57 percent (Upper Reach 'B') to a high of 94 percent (Upper Reach 'A'). Both Upper Reach 'B' (57 percent) and Lower Reach 'B' (67 percent) were rated as having fair overall bank stability. Based on soil texture survey results, relative

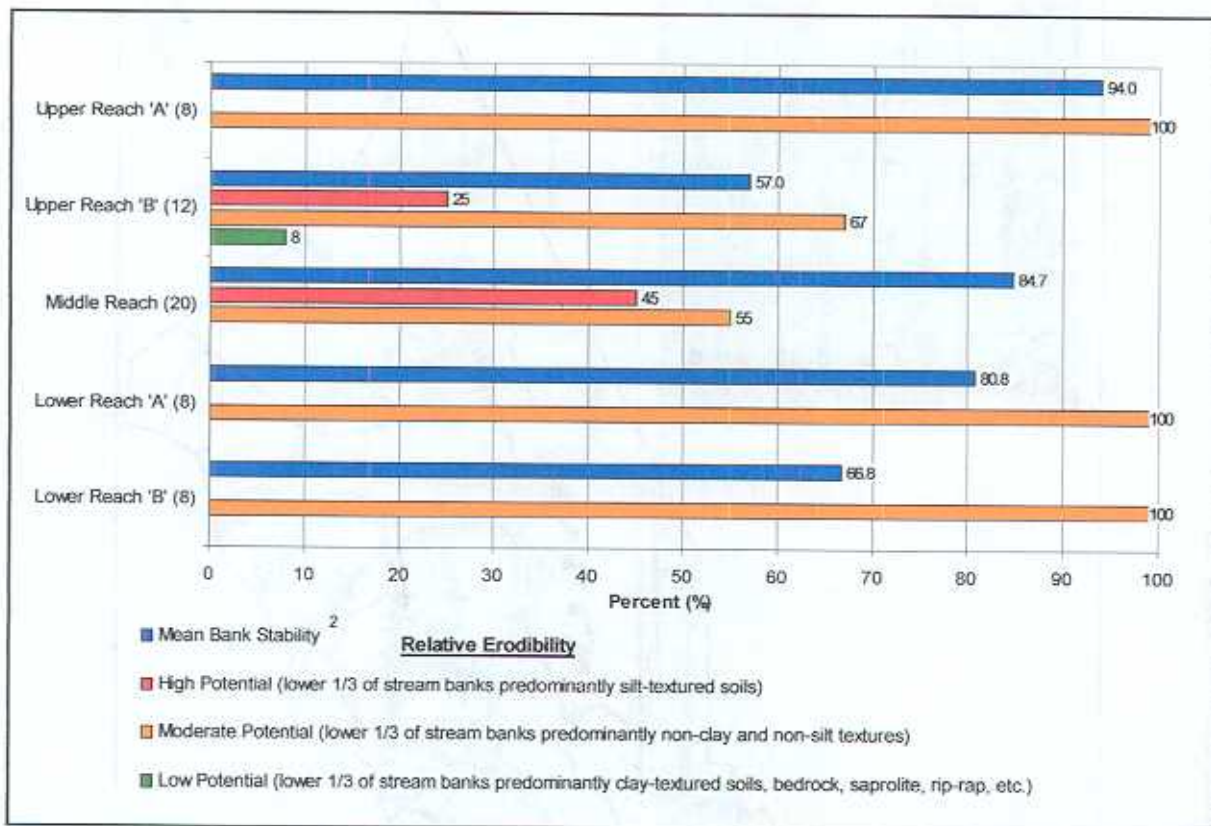
<sup>1</sup> Mean bank stability interpretation: >80% = Excellent, 71-80% = Good, 50-70% = Fair, <50% = Poor

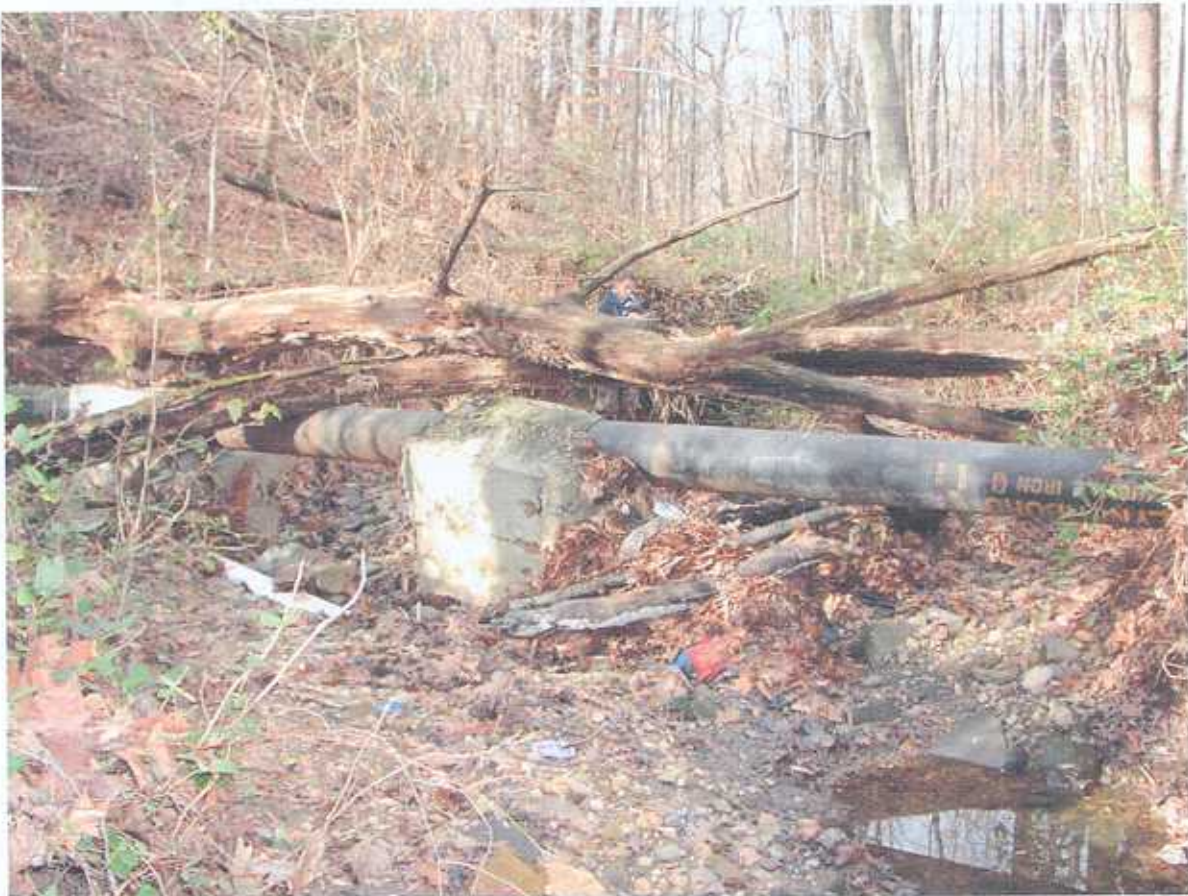
Figure 11 - Upper Reach 'B' - Undermined Sewer Line Support Pillars

Stream channel downcutting results (Table 5) revealed that Upper Reach 'A', Middle Reach and the two lower reaches fell either within or very close to the expected or reference condition stream bank height range. Conversely, mean bank heights for Upper Reach 'B' (average of 3.5 feet) were approximately 1.5 feet higher than expected. Also, as seen in Table 5, a total of seven nick points and seven exposed sewer lines were observed within the upper channel network. Five of these nick points were located within the Upper Reach 'A' area (i.e., the most stable section of Pope Branch). The vertical drops associated with these nick points ranged from 1.1 to 4.0 feet. Included within the Upper Reach 'B' channel is a major three-foot high nick point/debris jam located immediately downstream of the 'O' street 33-inch RCP storm drain outfall. All seven exposed sewer lines are located in this stream section (Figure 11). It should be noted that where a sewer line crosses a stream, the pipe is typically laid three to four feet below the invert of the streambed. Other findings are as follows: 1) approximately 22.0 percent of the Pope Branch channel network is moderately incised (i.e., bank heights 1.0-2.0 feet higher than the RSAT expected range), and 2) roughly 78.0 percent of the stream has experienced nominal degradation of its streambed (i.e., bank heights of 0.0 – 0.9 feet higher than the RSAT expected range).

1. The aging, main trunk sanitary sewer line which dates from the late 1930's and which parallels much of Pope Branch, has had a long history of both sewer line-related breaks and leaks. In fact, decades of uncontrolled stormwater runoff have, at several channel locations, severely compromised the structural integrity of the sewer system. This is particularly the case for the approximately 3,600 foot long Texas Avenue to Branch Avenue section. Given the overall age and condition of the sewer system, it is strongly recommended that DC-WASA either replace the trunk line in its entirety (i.e., construct a new relief sewer) or rehabilitate the existing pipe network via the employment of an Insituform® lining. Because the cost differential between the two options is relatively small for the existing 10 and 12-inch diameter Pope Branch trunk lines (i.e., approximately \$ 50-60/lf for pipe replacement versus \$45-55/lf for Insituform®), COG staff recommends the longer-lived replacement option. In addition, if at all possible this work should be done in concert with the restoration of Pope Branch's stream morphology.

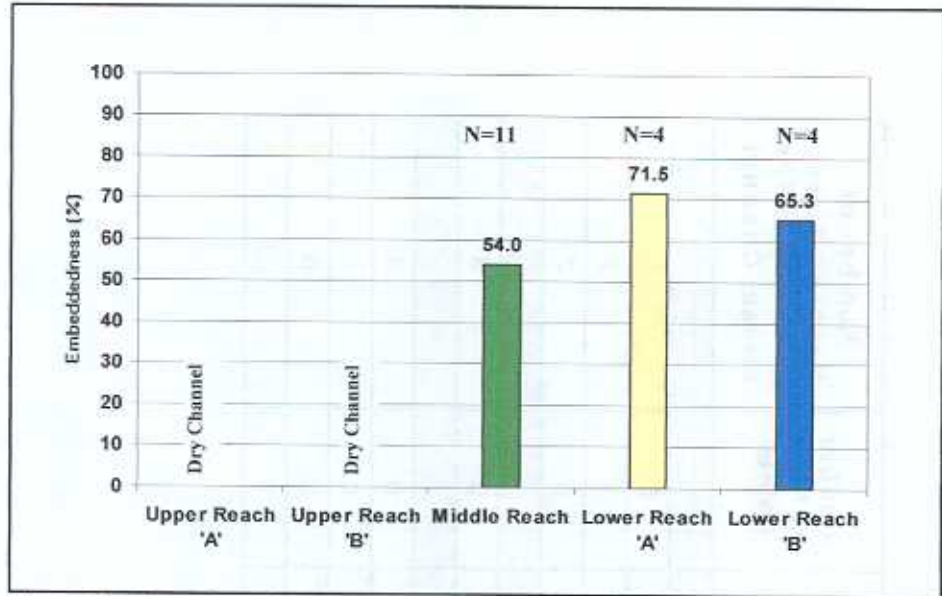
Figure 12 - Pope Branch - Mean Riffle Embeddedness Levels<sup>1</sup> (%)

As seen in Table 6, the Middle Reach recorded the highest total number of large unstable point bars (9). Lower Reach 'A' and 'B' totaled four and three unstable point bars, respectively. However, large unstable points bars presented as number per mile indicated that this rate is relatively constant, with 20.5 for the Middle Reach

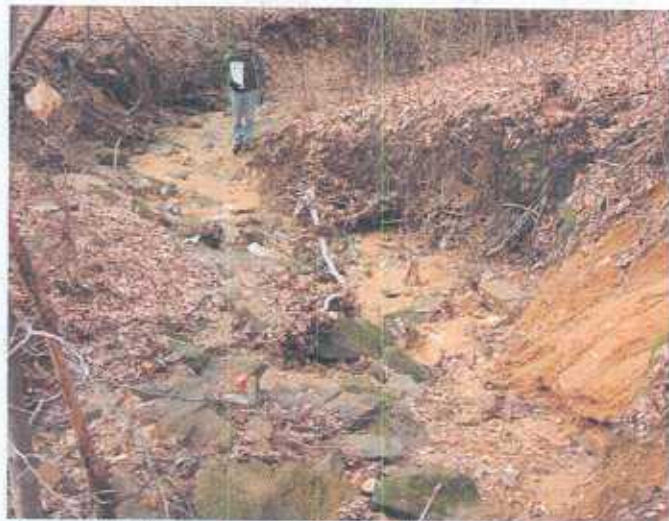
Figure 13 - Upper Reach 'B' - Bank Erosion Contributing to High In-Channel Sand Deposition

It should be noted that during the study period, Upper Reach 'A' and 'B' channel areas were dry and therefore channel scouring/sediment deposition conditions were not fully assessed. However, the relative level of in-channel sand deposits were noted for all five study reaches (Table 6). Not surprisingly, Upper Reach 'B' was rated as having high amounts of sand deposited within its channel (Table 6 and Figure 13). This finding is consistent with earlier observations which generally indicated that, vis-à-vis the other four Pope Branch reaches, this section is experiencing higher levels of stream channel erosion.

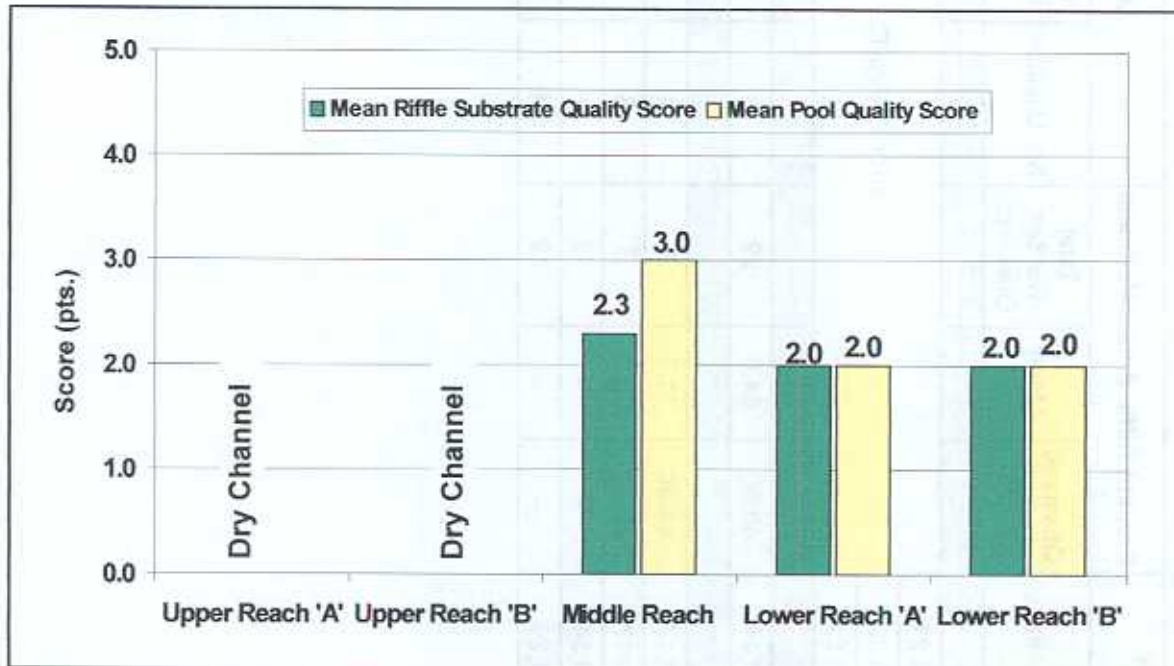
Figure 14 - Pope Branch Mean Riffle Substrate<sup>1</sup> and Pool Quality<sup>2</sup> Scores

<sup>1</sup> Riffle substrate quality point scale interpretation: 3.25-4.00 = Excellent, 2.50-3.24 = Good, 1.75-2.49 = Fair, 1.00-1.74 = Poor.

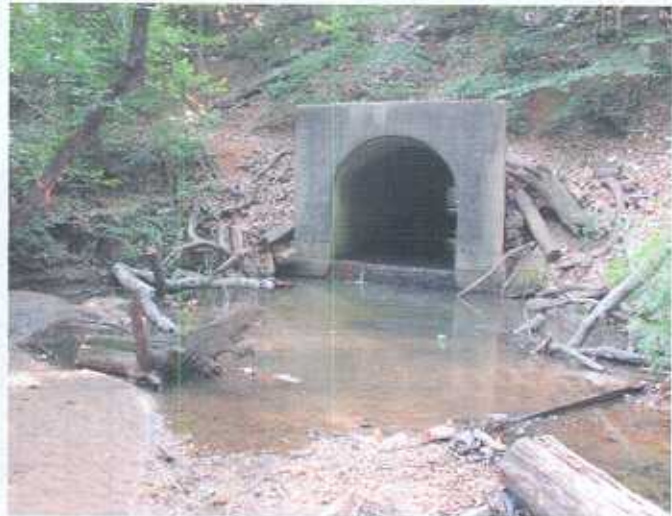
Figure 15 - Lower Reach 'B' - High Quality Deep Pool Below Minnesota Ave.

Other relevant findings area as follows: 1) a total of 12 pools (35 percent) were rated good or better with six located in both the Middle Reach and Lower Reach 'A' and 'B' areas; 2) the deepest pool, located immediately below Minnesota Avenue (Figure 15), had a maximum depth of 42 inches. Owing to the severity of the drought, this pool probably measured one to two inches shallower than under more normal baseflow conditions; and 3) the majority of the pools surveyed featured woody debris of varying sizes with large amounts of highly unstable sandy material.

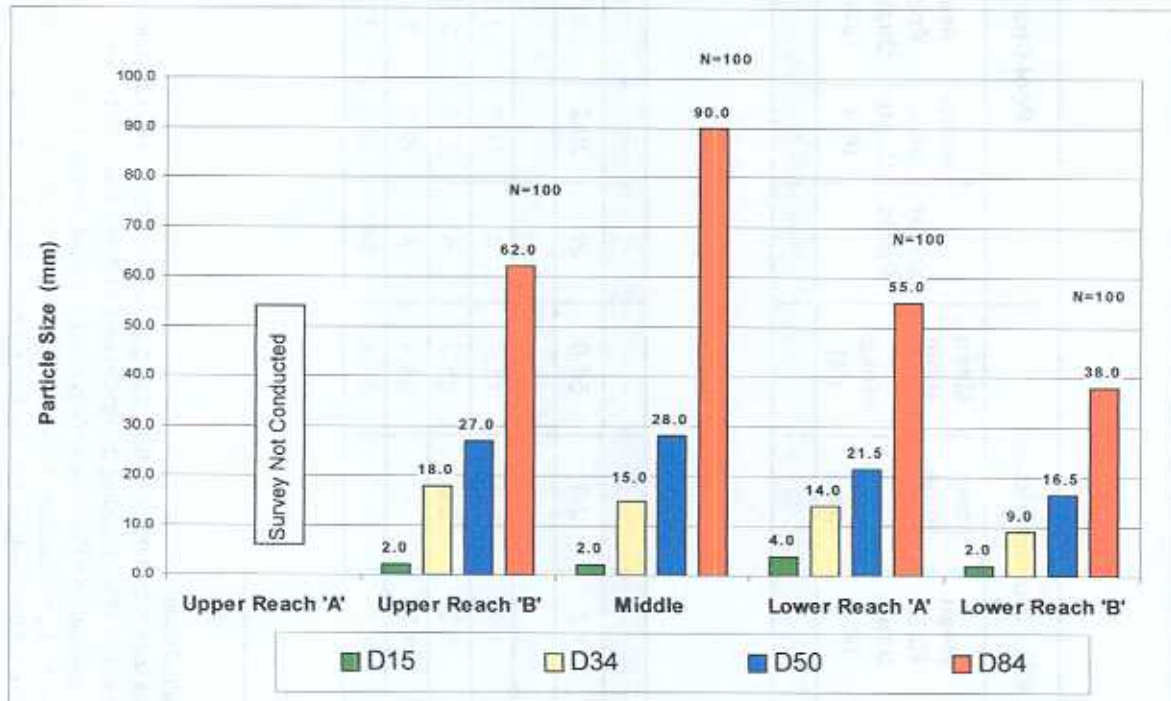
Figure 16 - Pope Branch - Substrate Particle Size Distribution<sup>1</sup> - D15, D34, D50, and D84 (N=100)

Substrate Class (AGI, 1982)	Very Fine Sand	Coarse Sand	Very Coarse Sand	Very Fine Gravel	Medium Gravel	Coarse Gravel	Very Coarse Gravel	Small Cobble	Large Cobble	Boulder	Bedrock
Size Range (mm)	0.06 – 0.13	1.00 – 1.31	1.01 – 1.99	2.00 – 7.99	8.00 – 15.99	16.00 – 31.99	32.00 – 63.99	64.00 – 127.99	128.00 – 255.99	256.00 – 4095.99	≥ 4096.00

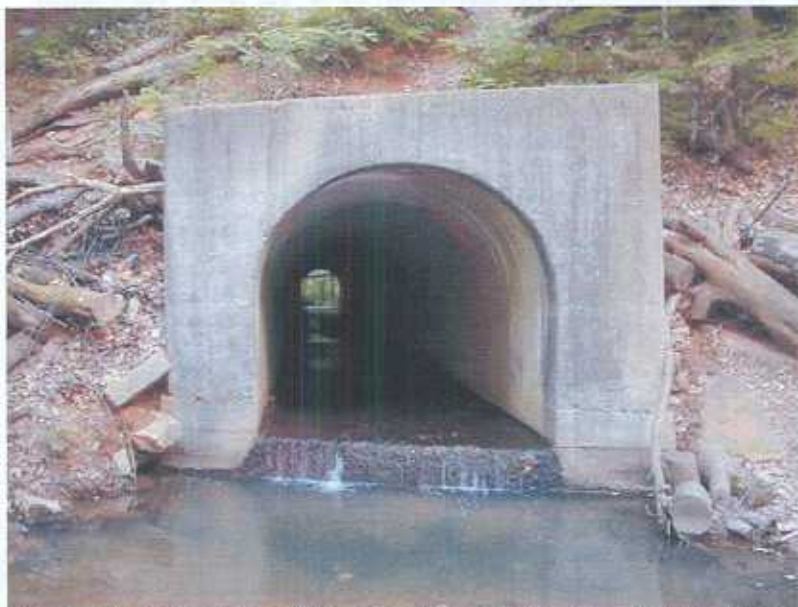
Figure 17 - Lower Reach 'B' - Complete Fish Barrier - 18.0-Inch Drop At Minnesota Avenue Culvert

In summary, seven (50 percent) of the observed fish barriers were associated with nick points. Three (21 percent) of the barriers were associated with concrete sewer lines. Two (14 percent) of the blockages were associated with perched road culverts at Minnesota and Branch Avenues, with each one featuring one to four foot drops, respectively. As depicted in Figure 17, the complete fish blockage at Minnesota Avenue culvert channel has a shallow depth of flow (i.e., roughly 1.0 inch deep) that terminates in an 18.0-inch drop. Without question, the single largest barrier to fish movement and migration within Pope Branch is the 1,385 foot long piped stream section downstream of Fairlawn Avenue (Figure 18, Site No. 14). As previously stated, this blockage precludes, with the lone exception of the American eel (*Anguilla rostrata*), the exchange of fish species between river and stream.<sup>10</sup>

- a. Lower Reach 'B' - Minnesota Avenue culvert, 1.5' drop, complete blockage (employ riffle grade control structure);

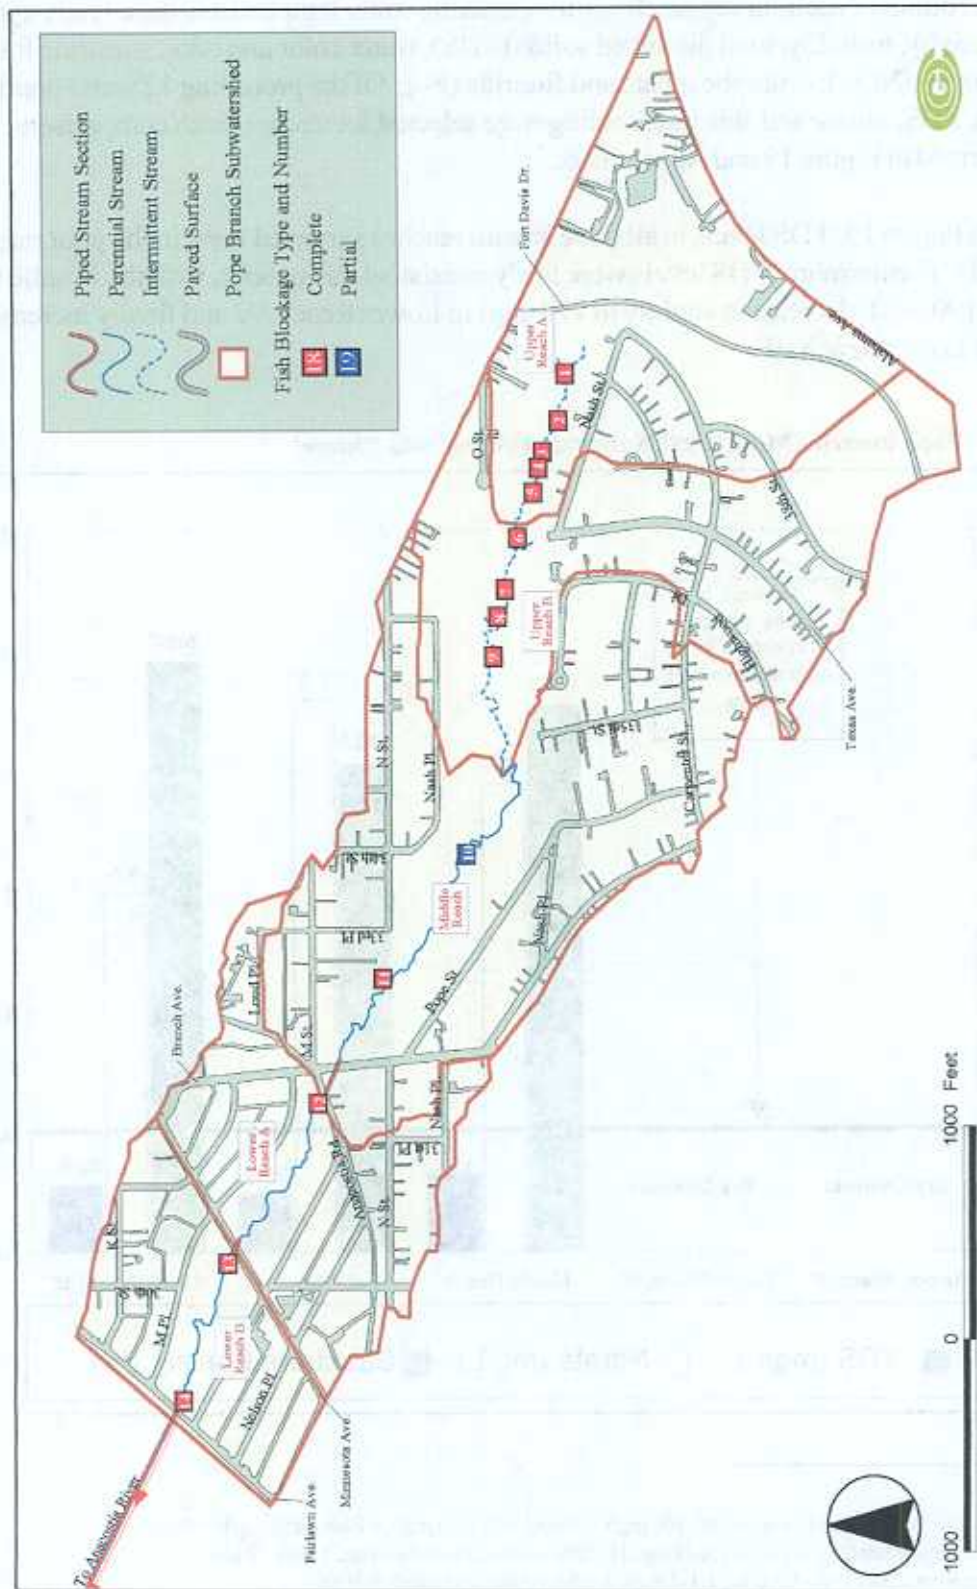
Figure 18 - Pope Branch - Fish Blockages<sup>1</sup>

<sup>1</sup> Numbers next to fish blockages correspond to Table 8.

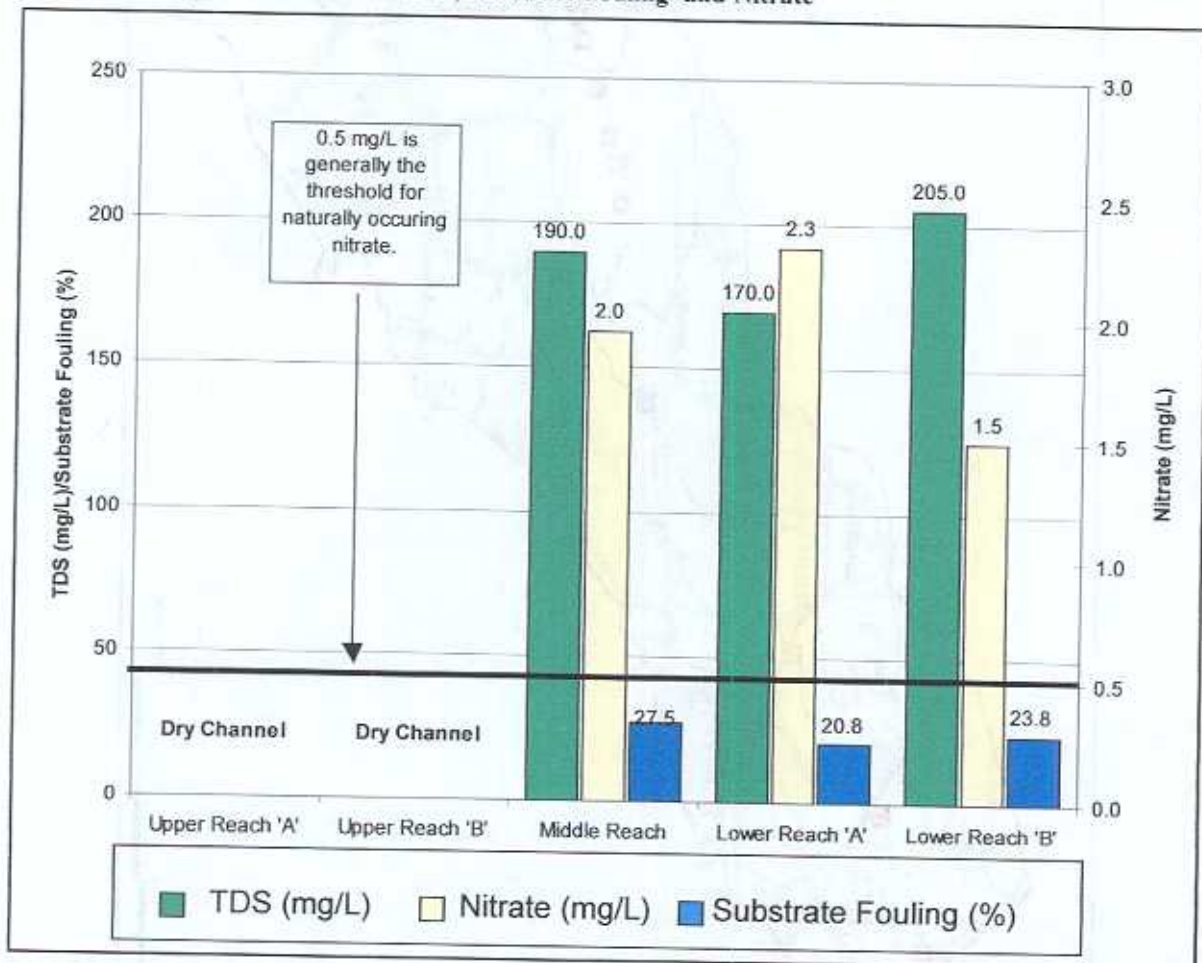
Figure 19 - Pope Branch - Mean TDS<sup>1</sup>, Substrate Fouling<sup>2</sup> and Nitrate<sup>3</sup>

<sup>1</sup> TDS interpretation:  $<50$  mg/L = Excellent, 50-100 mg/L = Good, 101-150 mg/L = Fair,  $>150$  mg/L = Poor.

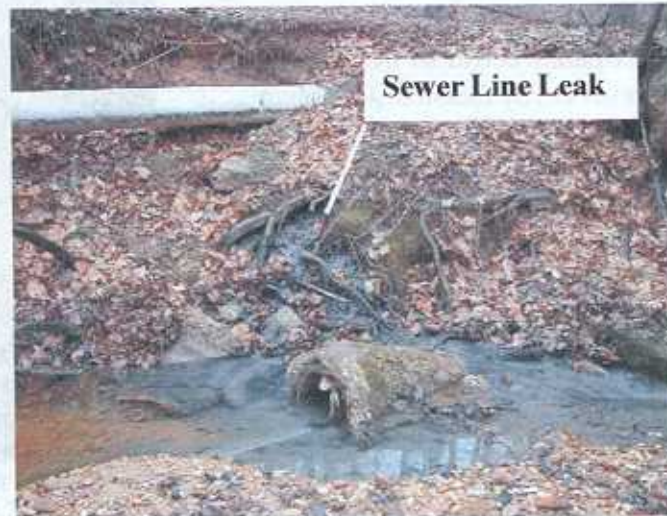
Figure 20 - Upper Reach 'A' - Sewer Line Leak Near 35<sup>th</sup> Street (January 2001)

The preceding results suggest low to moderate levels of organic loading/nutrient enrichment throughout Pope Branch. It should also be noted that spot fluoride readings revealed that both the Middle Reach and Lower Reach 'A' and 'B' areas periodically exceeded 0.3 mg/l (Appendix 6, Table 3). The highest fluoride reading (0.7 mg/l) occurred on August 2, 2002 in Lower Reach 'B'. Typically, natural background levels for fluoride in local surface waters are approximately 0.1 – 0.2 mg/l or less (Hannon, 1996; Thomas, 1966; Woll 1978; Otten and Hilleary, 1985), whereas concentrations of 0.3 mg/l or greater suggest the possible influence of either treated drinking water<sup>11</sup> or sewage.

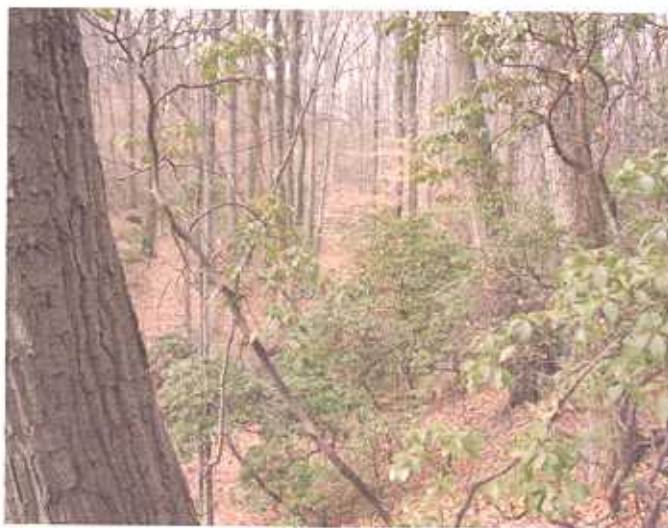
Figure 21 - Upper Reach 'A' and 'B' - Mature Hardwood Forest With Laurel Understory

With the exception of the Upper Reach 'A' left hand bank areas (i.e. left looking downstream), the Upper and Middle Reach riparian corridors were typically wide and heavily forested. As seen in Figure 21, a mature deciduous hardwood forest, with a laurel shrub understory was the dominant vegetative community in this portion of the stream valley. On average, the right bank riparian buffer width (181 feet) was considerably wider than that of the left bank (120 feet). In fact, 21 out of the 30 RSAT transect station sites (70 percent) featured forested riparian buffers 200 feet wide or greater for the right bank versus only 6 out of 30 (20 percent) for the left bank. It should be noted that along much of the left bank heading downstream, residential properties were frequently encroaching into the riparian buffer. Unfortunately, several of these areas included the illegal dumping of bulk trash items (i.e., mattresses, old sheds, couches, water heaters, etc.,) as well as the presence of non-native invasive plants such as English Ivy.

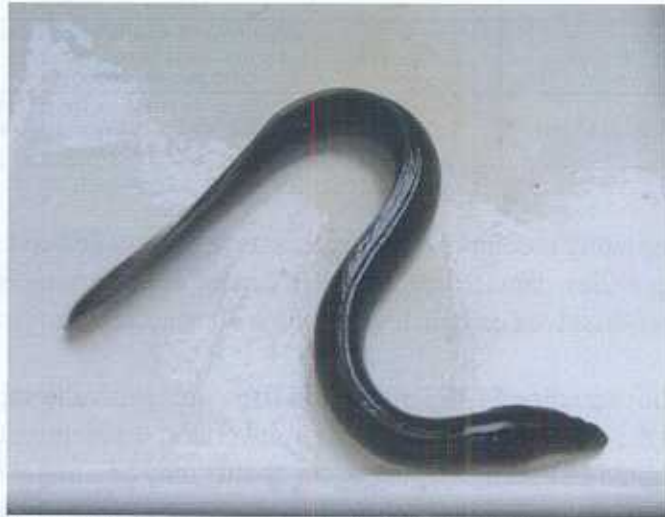
Figure 24 - Lower Reach 'B' - American Eel Elver Captured

As already noted, the planned summer 2002 mainstem electrofishing survey was not performed. During many site visits, COG staff observed no fish in the Upper or Middle reaches, and captured only one small (approximately 8 inches-long) American eel, *Anguilla rostrata*, elver in Lower Reach 'B' (Figure 24). The only other vertebrates collected from Pope Branch were larvae of the northern two-lined salamander, *Eurycea bislineata*, which were relatively scarce. The preceding results confirmed that: 1) the Pope Branch system is currently not supporting a resident fish community and 2) the 1,385 foot long pipe section

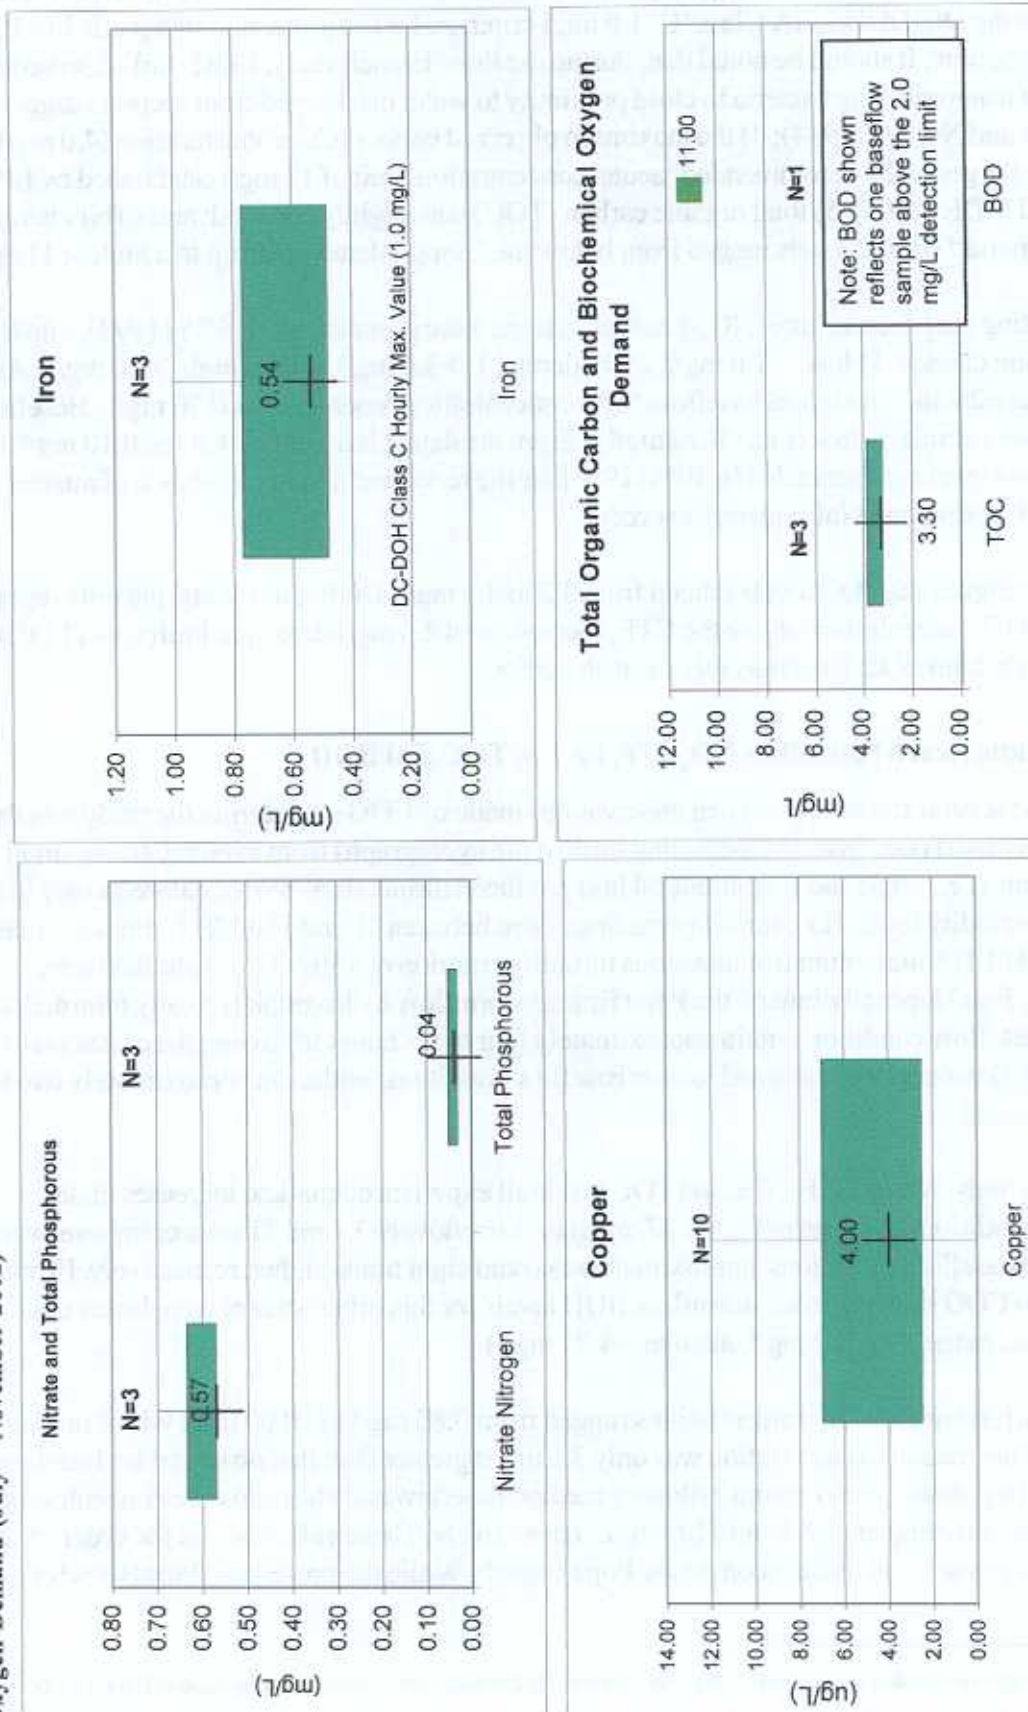
Figure 26 - Pope Branch Lower Reach 'A' (Transect X-26) Baseflow Nitrate, Total Phosphorus, Copper, Iron, Total Organic Carbon, and Biochemical Oxygen Demand (July - November 2002)

Limited baseflow laboratory water chemistry analysis summary results (Figure 26; Appendix 6: Table 1) for Pope Branch Lower Reach 'A' (X-26) revealed that: 1) nitrate (NO<sub>3</sub>-) concentrations

were in the moderate range; 2) total phosphorus (TP) concentrations were low; 3) iron (Fe) levels were below the DC-DOH/EHA Class 'C' 1.0 mg/l criterion for the protection of aquatic life 100 percent of the time. It should be noted that, during the Pope Branch study, COG staff observed the presence of iron-oxidizing bacteria in close proximity to water discharged from seeps as suggested by Robbins and Norden (1994); 4) the maximum observed copper (Cu) concentration (4.0 mg/l) was well below the generally recommended 'acute' concentration limit of 13 mg/l established by EPA (2002); and MDE (2003); 5) total organic carbon (TOC) was slightly elevated; and 6) biochemical oxygen demand<sup>14</sup> (BOD) levels ranged from below the 2.0mg/l detection limit to a high of 11.0mg/l.

For reporting purposes, nitrate ( $\text{NO}_3^-$ ) concentrations were grouped, per USGS (1993), into three concentration classes: 1) low, < 1.0 mg/l, 2) moderate, 1.0-3.0 mg/l, and 3) high, >3.0 mg/l. As seen in Figure 26, the maximum baseflow  $\text{NO}_3^-$  concentration recorded was 0.70 mg/l. Baseflow TP levels were similarly low (i.e., <0.10 mg/l). From the data it is apparent that the 0.10 mg/l TP concentration level recommended by EPA (1986) for the reduction and/or avoidance of nuisance plant growth in streams is infrequently exceeded.

As seen in Figure 26, TOC levels ranged from 3.2 to 4.4 mg/l. During the study, the only reported baseflow BOD concentration above the CTE, Incorporated 2.0 mg/l detection limit was 11.00 mg/l. This relatively high BOD level may represent an outlier.
