# **Pope Branch Subwatershed Restoration: 2002 Baseline Stream Assessment Study – Physical, Chemical, and Biological Conditions**

**Prepared for:  
District of Columbia  
Department of Health/  
Environmental Health Administration  
Watershed Protection Division**

**Prepared by:  
Department of Environmental Programs  
Metropolitan Washington Council of Governments**

**May 2003**

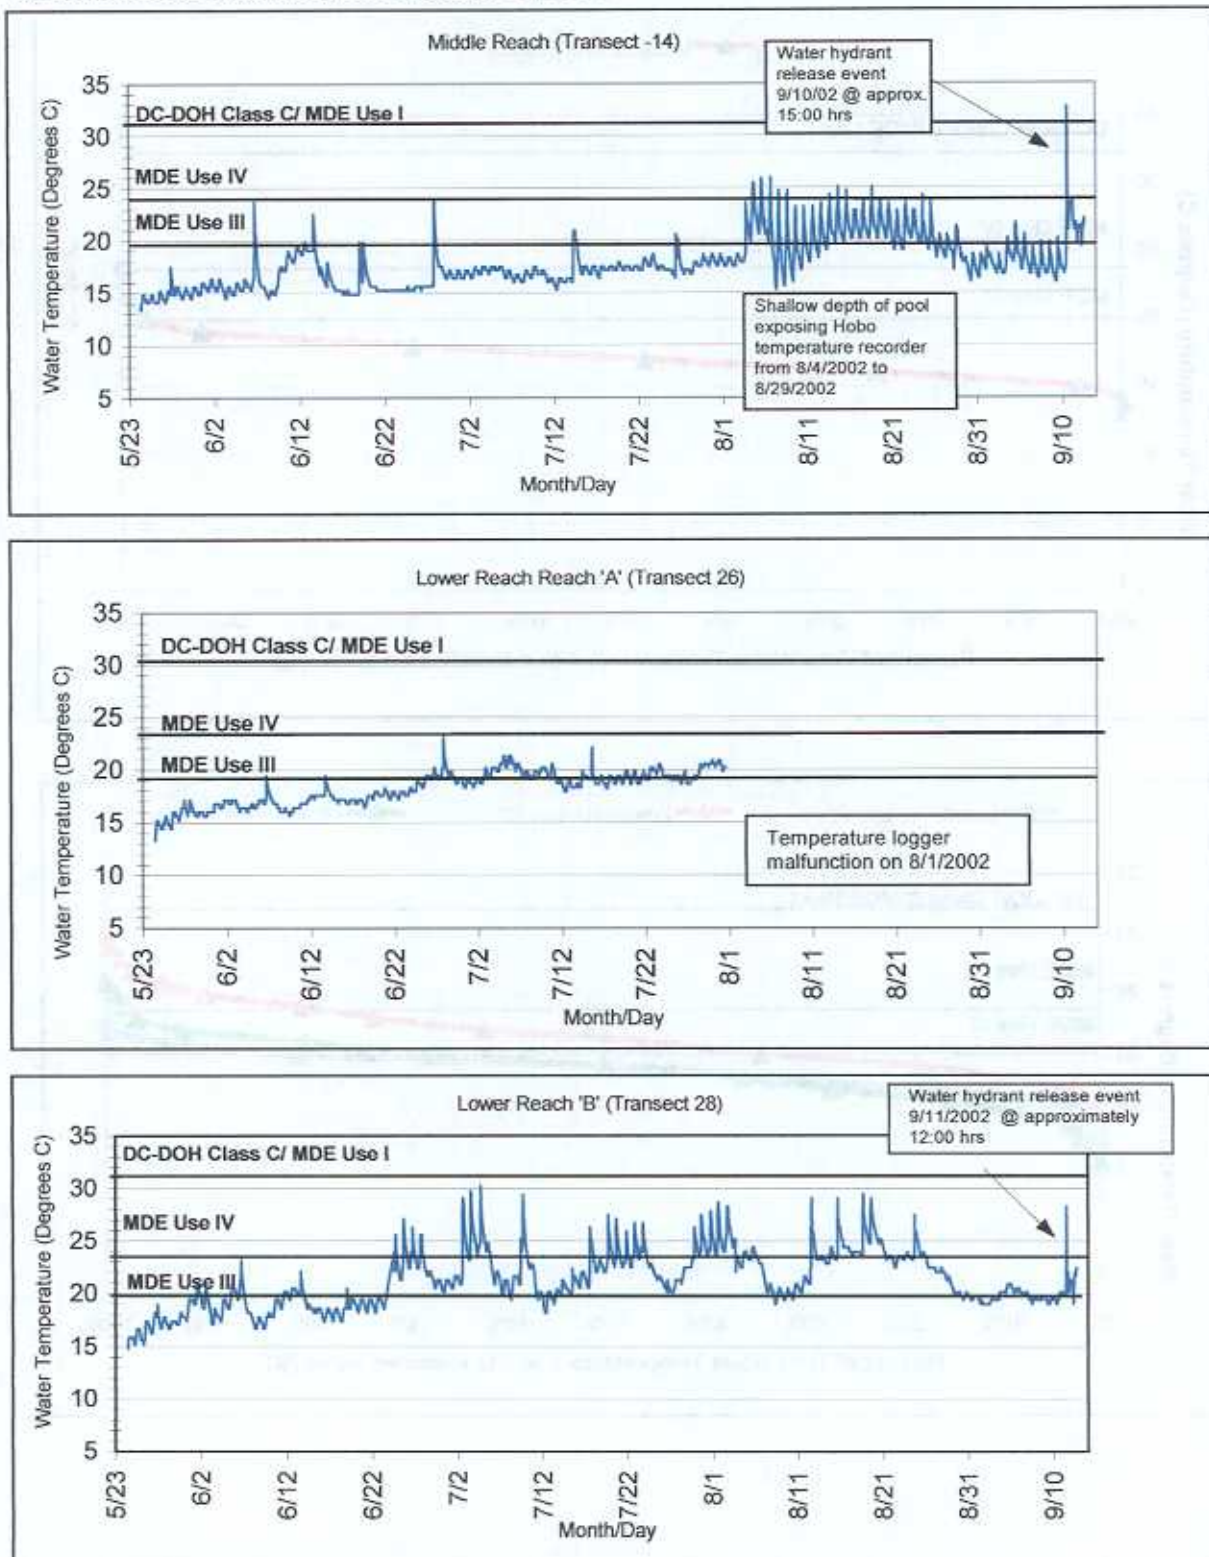
Figure 28 - Pope Branch - Middle, Lower Reach 'A', and Lower Reach 'B' Twenty-Minute Water Temperature Readings<sup>1</sup> (May 24-September 12, 2002)

<sup>1</sup> DC-DOH Maximum Water Temperature Standards: Class-Protection and propagation of fish, shellfish and wildlife = 32.2°C. MDE Maximum Water Temperature Standards: Use I (water contact recreation, aquatic life and water supply) = 32°C; Use III (natural trout waters) = 20°C; Use IV (recreational trout waters) = 24°C.

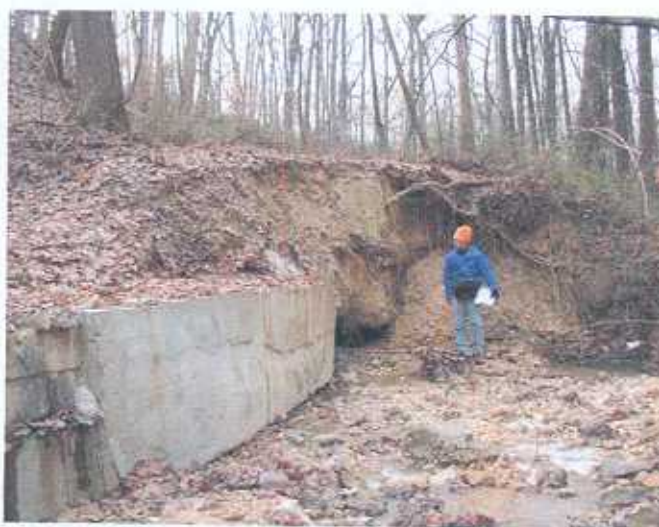
Figure 32 - Pope Branch - Upper Reach 'B' - Undercut Sewer Manhole

In addition, as graphically illustrated by Figure 32, the structural deterioration of the 3,600 feet long nearly 70-year-old sewer line section which parallels and traverses both the Upper Reach 'B' and Middle Reach Appendix 8) areas poses an imminent threat to the stream and its biota. Correcting this problem in an expeditious manner would help improve existing water quality, as well as benefit any future restoration project aimed at restoring physical and aquatic community conditions in Pope Branch.

1. The aging, main trunk sanitary sewer line which dates from the late 1930's and which parallels much of Pope Branch, has had a long history of both sewer line-related breaks and leaks. In fact, decades of uncontrolled stormwater runoff have, at several channel locations, severely compromised the structural integrity of the sewer system. This is particularly the case for the approximately 3,600 foot long Texas Avenue to Branch Avenue section. Given the overall age and condition of the sewer system, it is strongly recommended that DC-WASA either replace the trunk line in its entirety (i.e., construct a new relief sewer) or rehabilitate the existing pipe network via the employment of an Insituform® lining. Because the cost differential between the two options is relatively small for the existing 10 and 12-inch diameter Pope Branch trunk lines (i.e., approximately \$ 50-60/lf for pipe replacement versus \$45-55/lf for Insituform®), COG staff recommends the longer-lived replacement option. In addition, if at all possible this work should be done in concert with the restoration of Pope Branch's stream morphology.

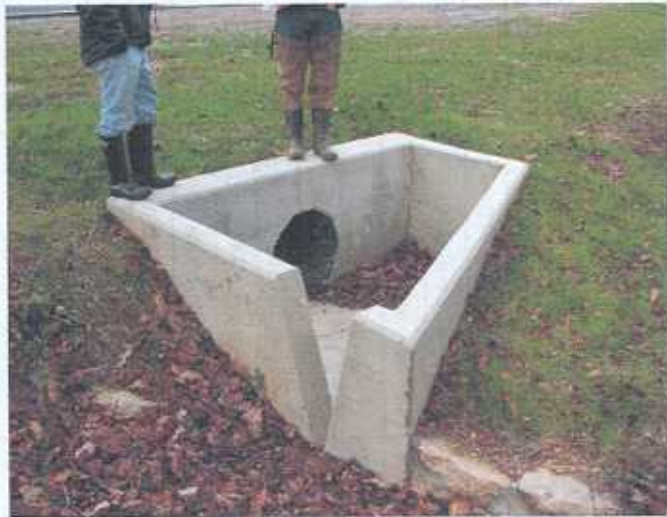
Figure 33 - Fort Davis Drive Storm Drain System - Flow Regulating Weir

Among the priority stormwater runoff/storm drainage problem areas to consider for both future stormwater management and storm drain outfall retrofitting are the 'O' Street, Texas Avenue, 35<sup>th</sup> Street, and Branch Avenue sub-catchments. These drainage areas contribute significant volumes of uncontrolled runoff and pollutants to Pope Branch. While the stream should respond well to the installation of both effective stormwater management and velocity dissipation techniques (e.g., Figure 33), widespread implementation will be extremely challenging. Therefore, a comprehensive stream restoration approach which also includes major reconstruction of Pope Branch's stream channel morphology so as to better meet its altered urban stream flow and sediment transport regimes will also be required.

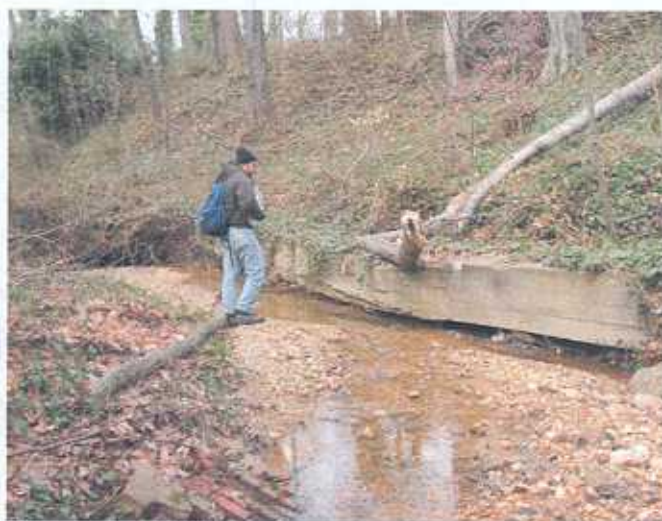
Figure 35 - Middle Reach - Existing Sewer Line and Concrete Encasement Condition

1. The aging, main trunk sanitary sewer line which dates from the late 1930's and which parallels much of Pope Branch, has had a long history of both sewer line-related breaks and leaks. In fact, decades of uncontrolled stormwater runoff have, at several channel locations, severely compromised the structural integrity of the sewer system (Figure 35). This is particularly the case for the approximately 3,600 foot long Texas Avenue to Branch Avenue section (Appendix 8). Given the overall age and condition of the sewer system, it is strongly recommended that DCWASA

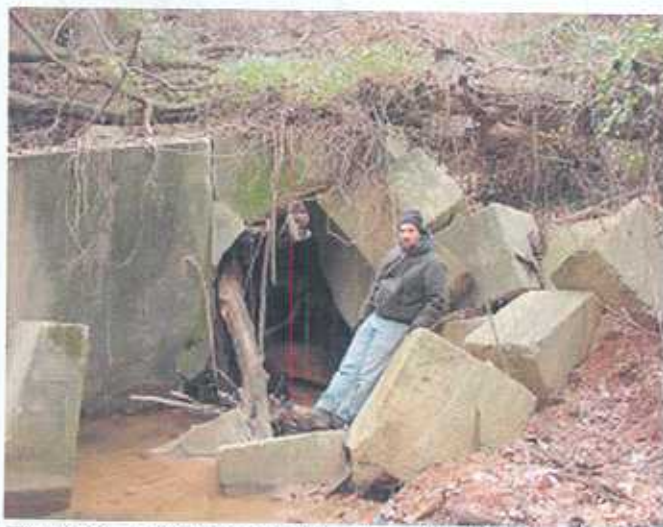
Figure 36 - Lower Reach 'B' - Complete Fish Barrier - Branch Avenue Culvert Endwall

3. The inadvertent collapse of the endwall section of the 8'x 8' Branch Avenue concrete arch culvert (Figure 36) is providing defacto stormwater management quantity control for both Lower Reach 'A' and 'B' (i.e., the original cross-sectional area has been effectively reduced to an approximately 2'x 8' opening). While this collapsed section should be repaired it is recommended that, as part of the repair project, DC-DOH/EHA and DC-DPWT

3. The inadvertent collapse of the endwall section of the 8'x 8' Branch Avenue concrete arch culvert is providing defacto stormwater management quantity control for both Lower Reach 'A' and 'B' (i.e., the original cross-sectional area has been effectively reduced to an approximately 2'x 8' opening). While this collapsed section should be repaired it is recommended that, as part of the repair project, DC-DOH/EHA and DC-DPW investigate the possibility of constructing a formal, flow-reducing weir on the upstream side of the culvert.

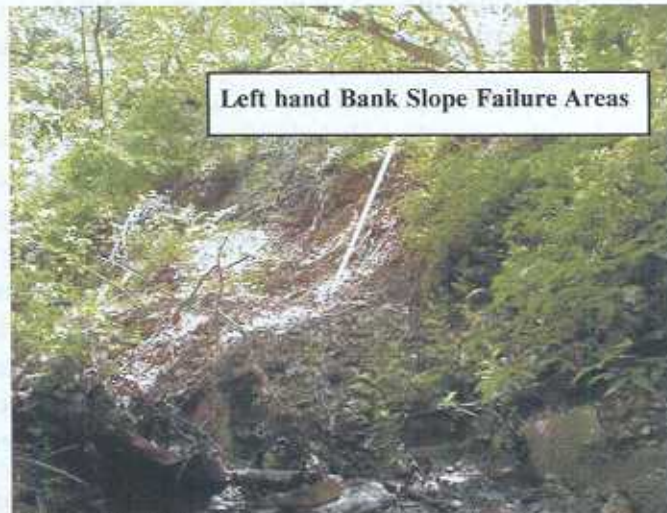
Figure 41 - Middle Reach - Left Hand Bank Slope Failure Area

11. The boulder/rubble fill slope located along the left hand bank in the Middle Reach X-14 to X-18 area is exhibiting signs of localized slope failure. In COG staff's opinion, a geotechnical study should be undertaken of this area to determine its potential long-term stability.
