Technical Memorandum

Anacostia Tributary Streambank Erosion Study

Phase II-A

Upper Beaverdam and Indian Creek Subwatersheds

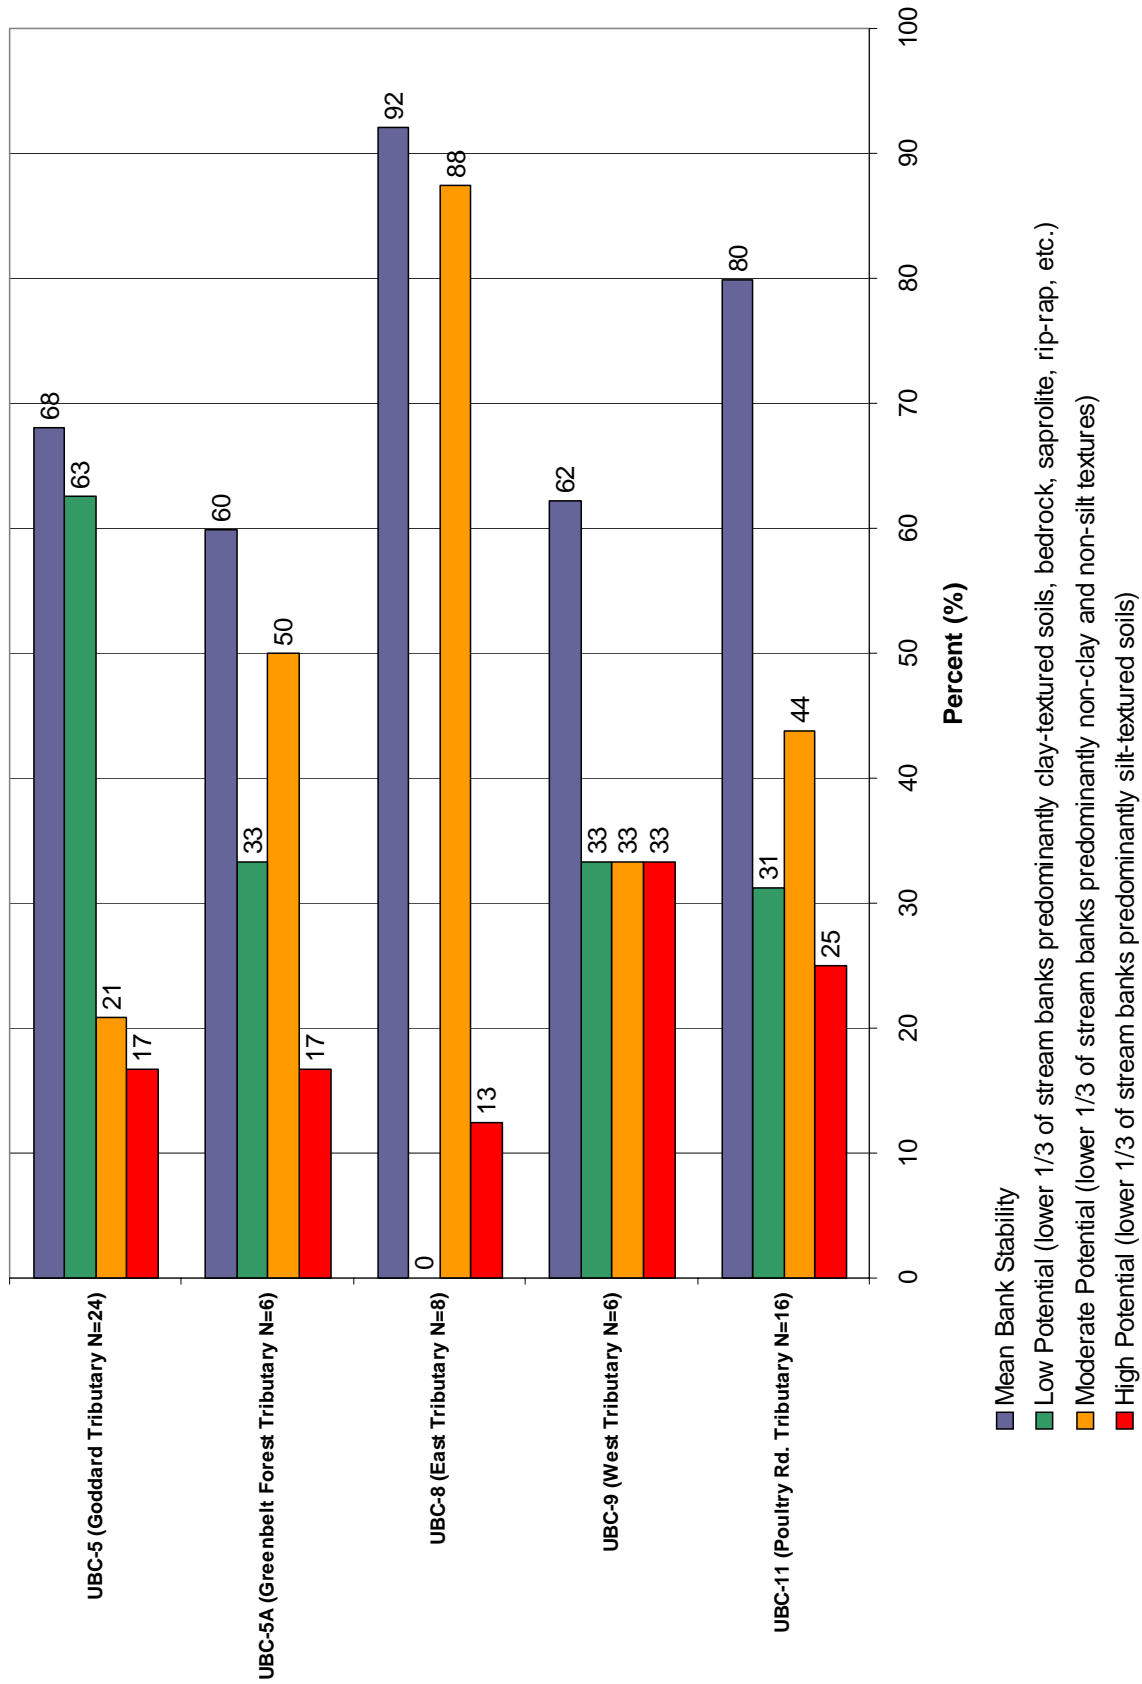
Figure 23: Upper Beaverdam Creek Tributary System Mean Streambank Stability¹ and Relative Erodibility² (%)

¹ Mean bank stability interpretation: >80% = Excellent, 71-80% = Good, 50-70% = Fair, <50% = Poor.

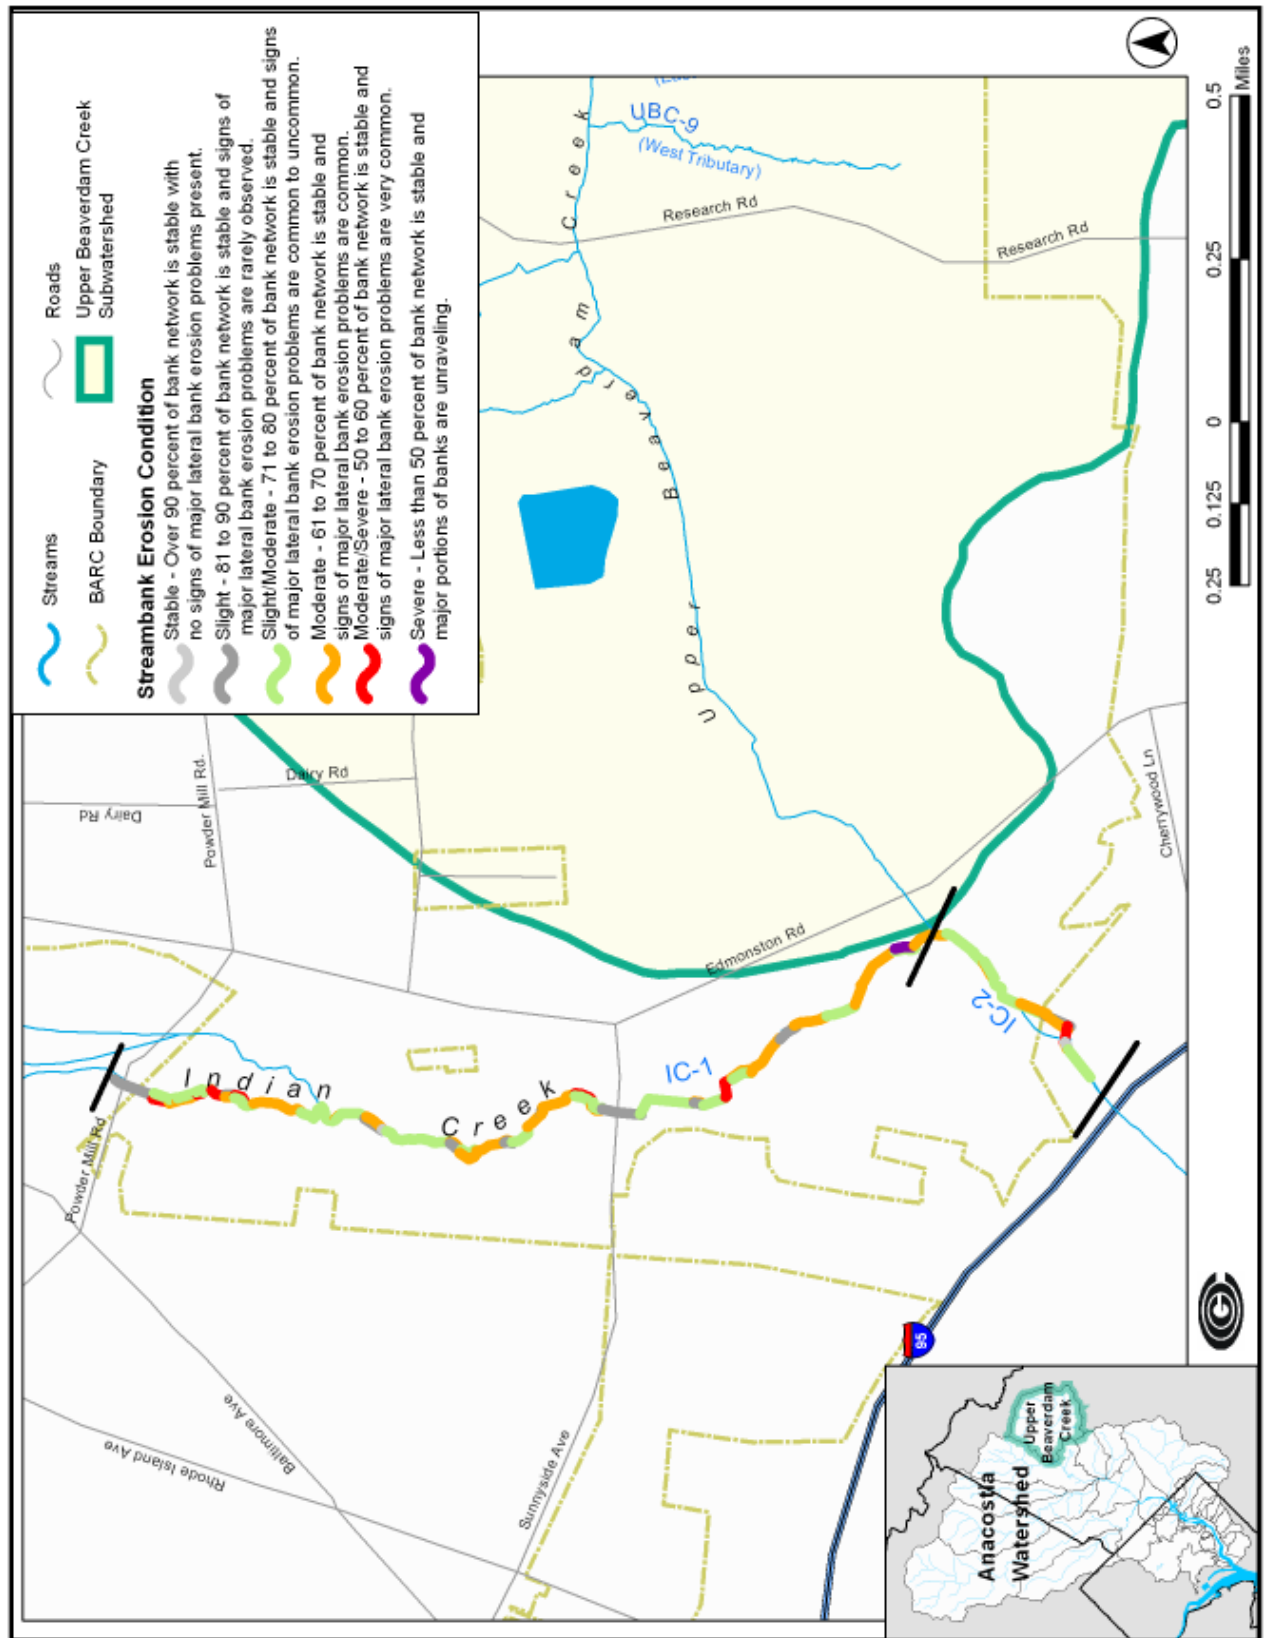
Figure 24: Location - Summary: Indian Creek Mainstem Streambank Erosion Condition

Streambank stability results are summarized in Table 3 and Figure 24. Also, representative photographs depicting bank conditions for the tributary areas are presented in Figures 25 through 32. Mean streambank stability for IC-1 (Powder Mill Road to Upper Beaverdam Creek confluence) and IC-2 (Upper Beaverdam Creek confluence to 0.7 miles downstream) (i.e., 68.2 and 75.3 percent, respectively) were rated as being fair to good.

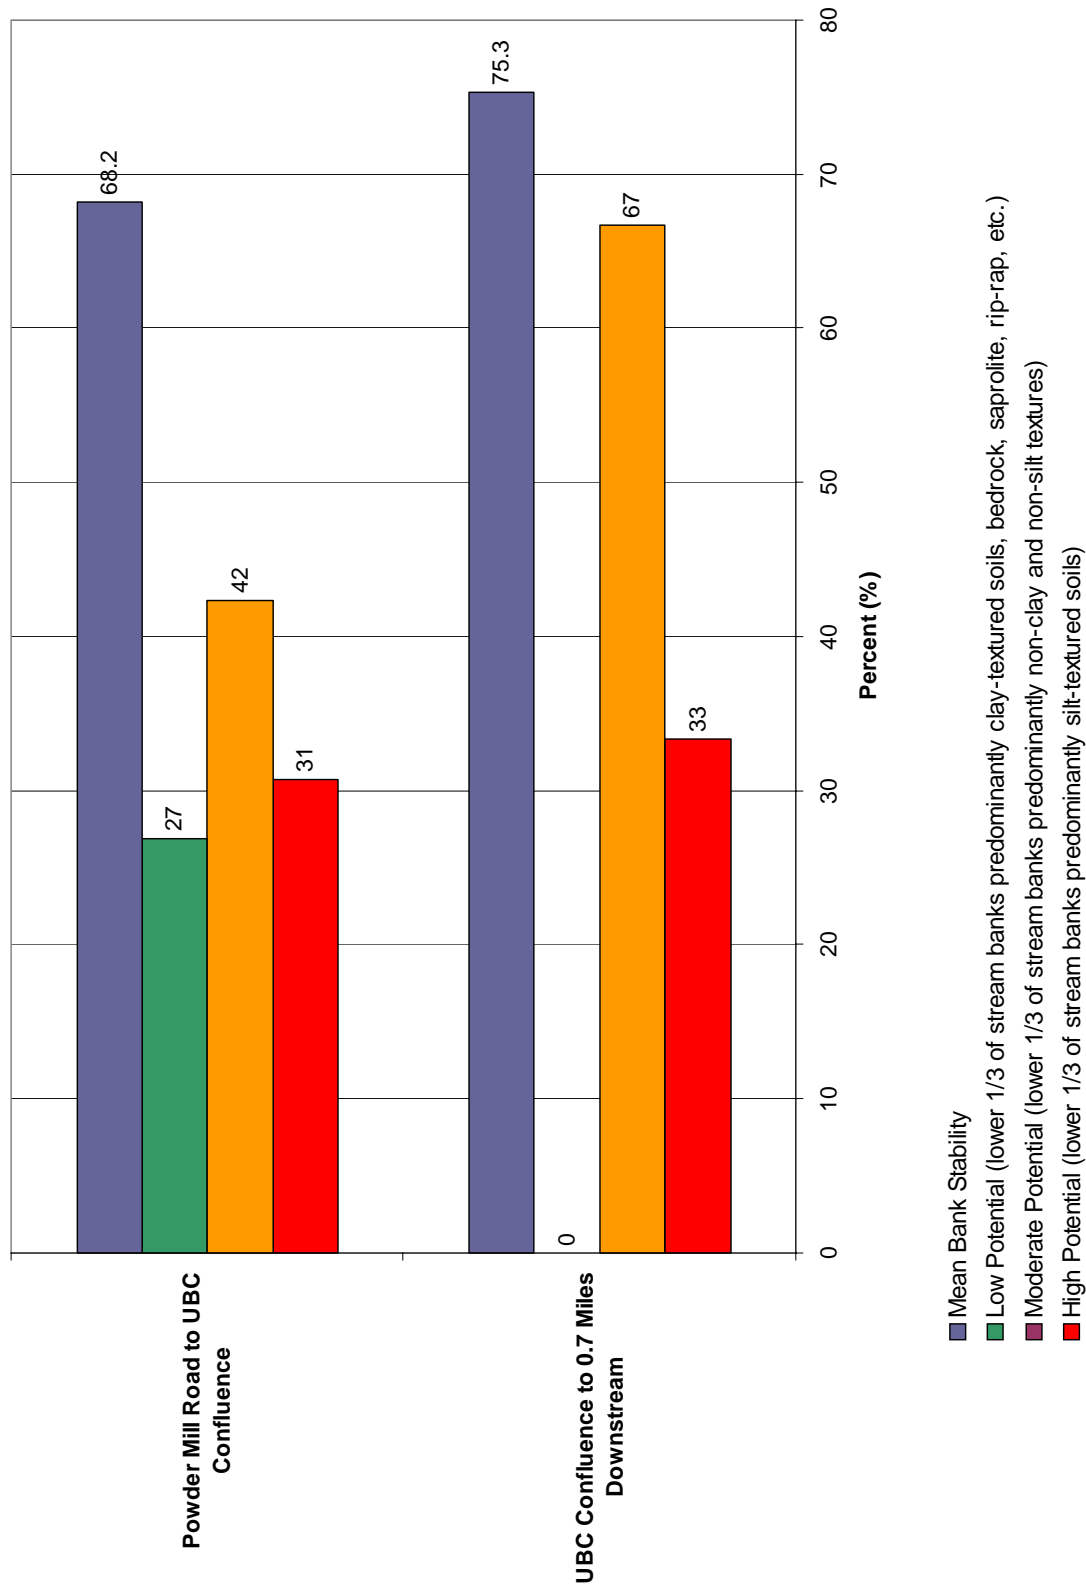
Figure 33: Indian Creek Mean Streambank Stability¹ and Relative Erodibility² (%)

RSAT streambank soil relative erodibility results for the surveyed portion of the Indian Creek mainstem (Figure 33) revealed that the bank material present are, in order of dominance, moderate (i.e., generally loam-textured soils), high (i.e., generally sand/silt-textured soils) and low (i.e., generally clay-textured soils).

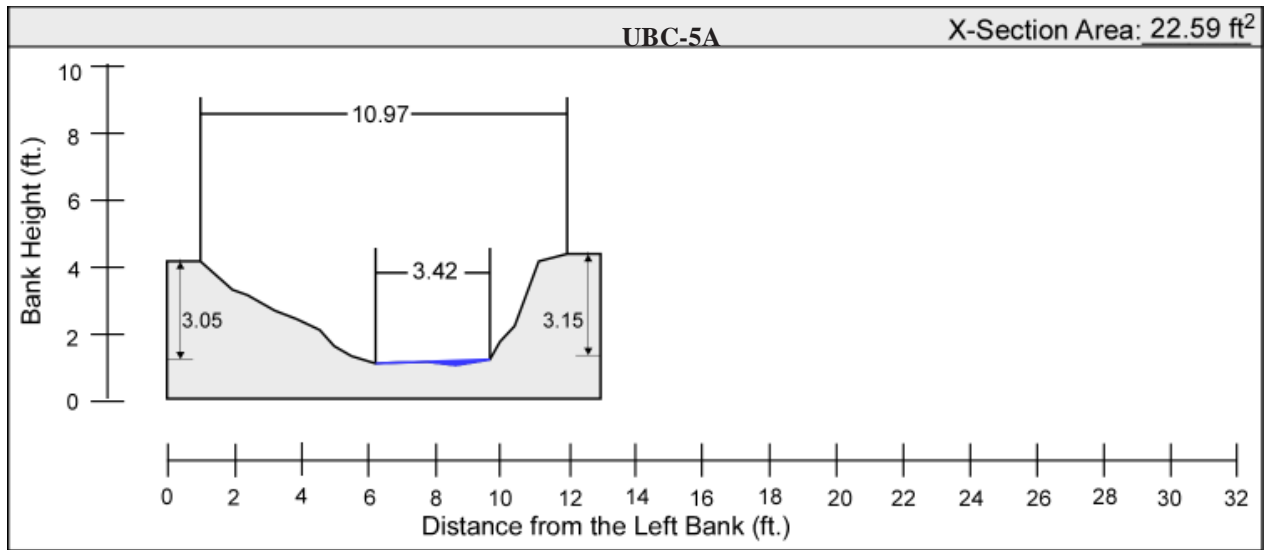
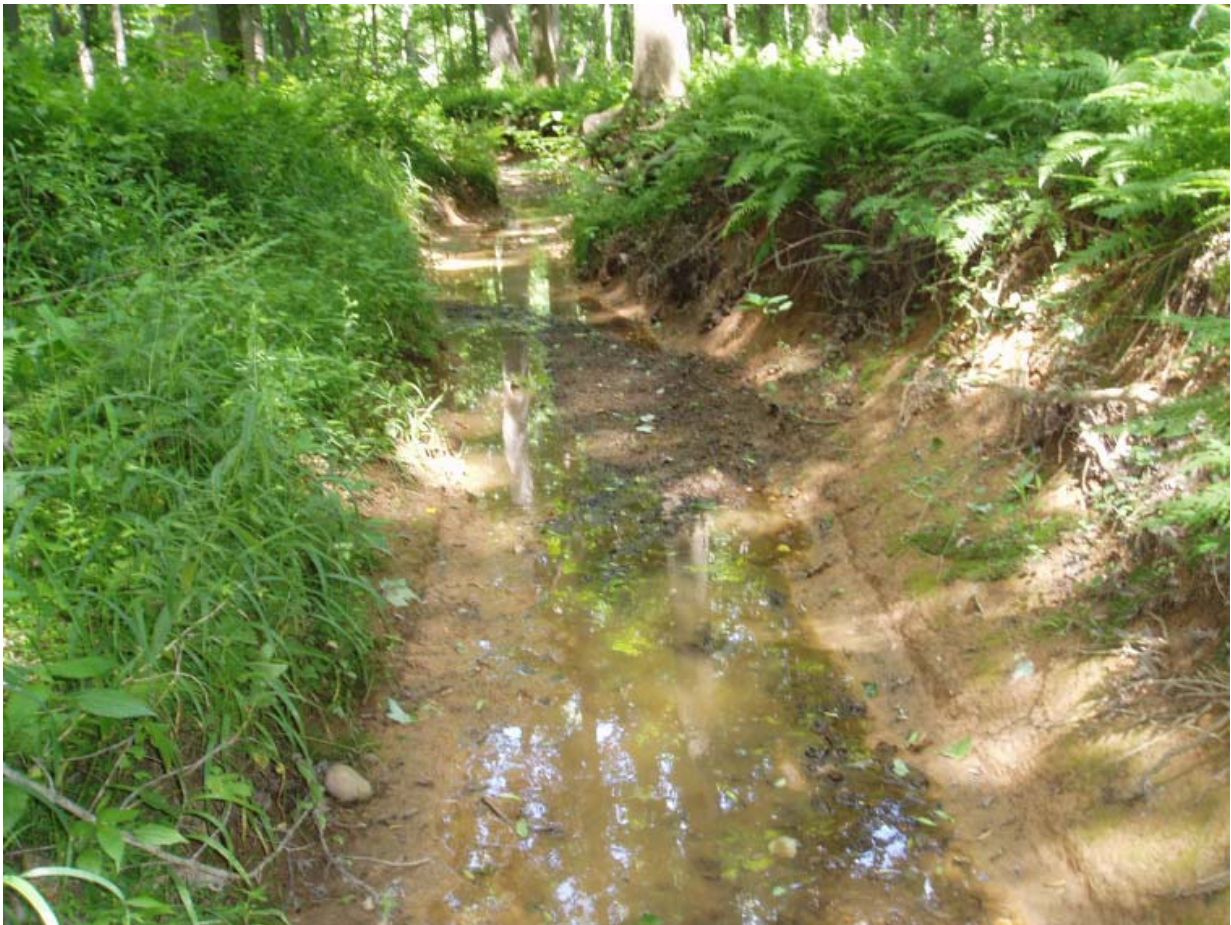
Figure 34: Representative Cross Section and Photograph for (Greenbelt Forest Tributary) to UBC-5¹Location: Approximately 260 feet above Goddard tributary confluence²

Cross-sectional analysis results revealed that the mean cross-sectional area of the Upper Beaverdam Creek tributaries are as follows: UBC-5 = 68.67 ft², UBC-5A = 25.94 ft², UBC-8 = 10.93 ft², UBC-9 = 41.71 ft² and UBC-11 = 47.96 ft². With the exception of UBC-8 (East Tributary), tributary channel widths and bank heights were all (for their respective drainage areas) generally wider and higher than their expected or reference condition. Specifically, mean tributary streambank heights were on the order of one to 2.5 feet higher than the expected or reference bank height ranges (i.e., 1-2 feet). Notably, the highly entrenched UBC-5 (Goddard Tributary) and UBC-9 (West Tributary) exhibited mean bank heights which were approximately 2.5 feet or higher than expected bank height range. Figures 34 through 37 illustrate selected mainstem cross-sections.

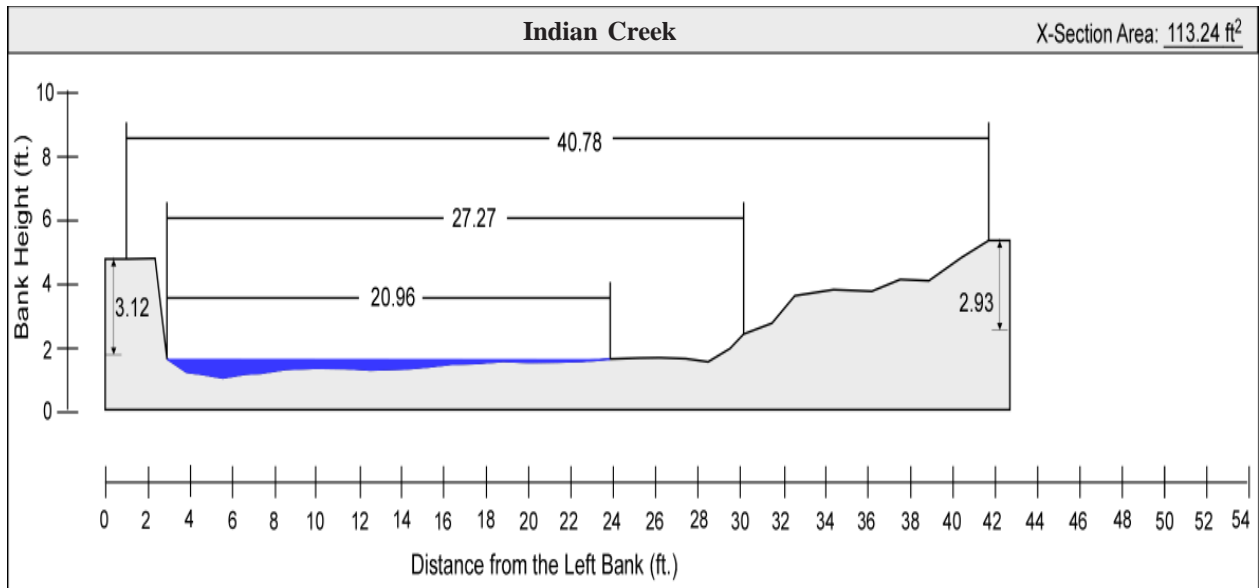
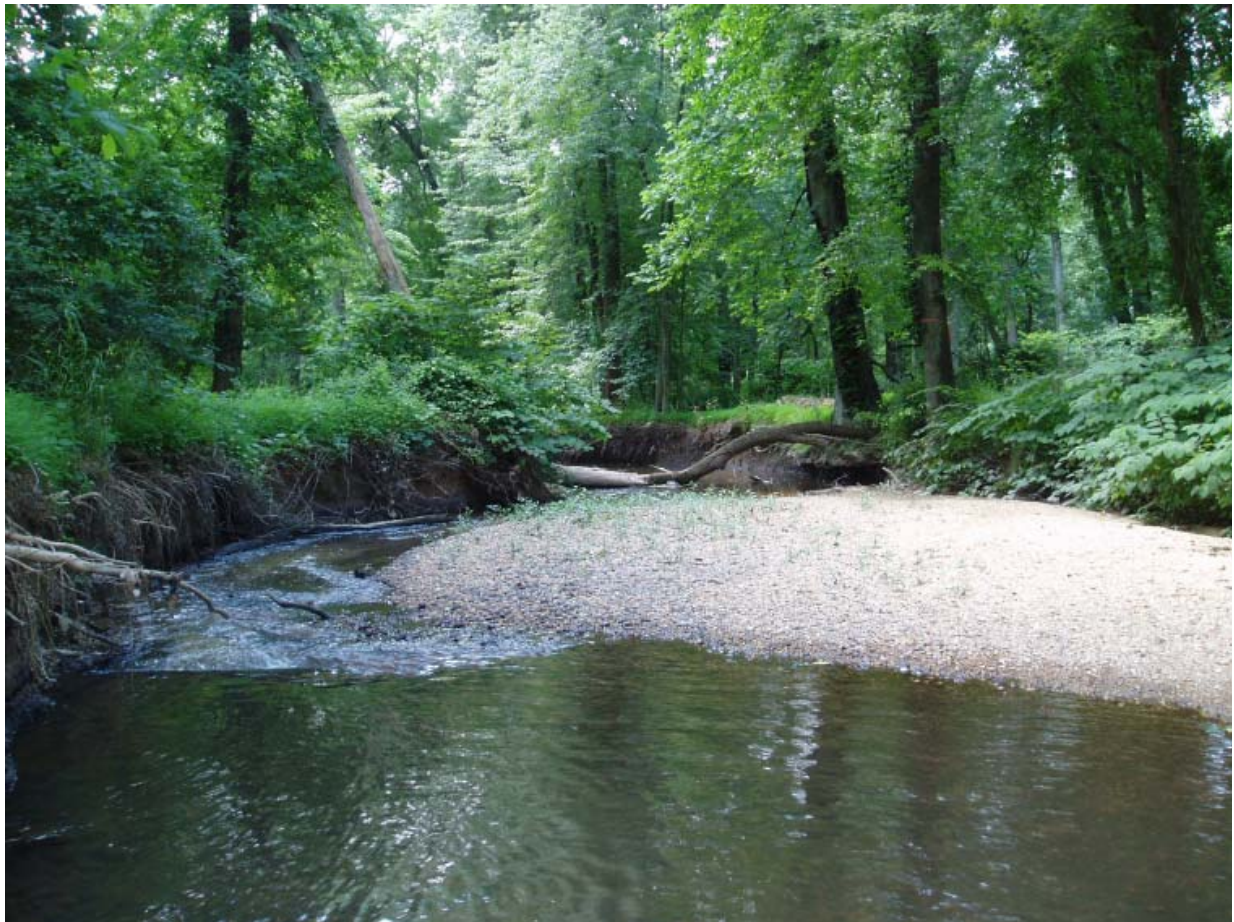
Figure 38: Representative Cross Section and Photograph for IC-1 (Powder Mill Road to UBC Confluence)¹Location: Approximately 400 feet above confluence with Upper Beaverdam Creek Mainstem ²

Indian Creek stream mean cross-sectional area results are as follows: IC-1 (Powder Mill Road to Upper Beaverdam Creek confluence) = 88.48 ft², and IC-2 (Upper Beaverdam Creek confluence 0.7 miles downstream) = 136.97 ft². Both IC-1 and IC-2 fell within the expected or referenced condition bank height range of three to four feet. Figure 38 illustrates a representative mainstem cross-section located within the IC-1 surveyed segment.
