**CITY OF TAKOMA PARK
WATERSHED IMPLEMENTATION PLAN
NARRATIVE REPORT SUBMITTAL**

November 18, 2011

Takoma Park WIP Strategy Description

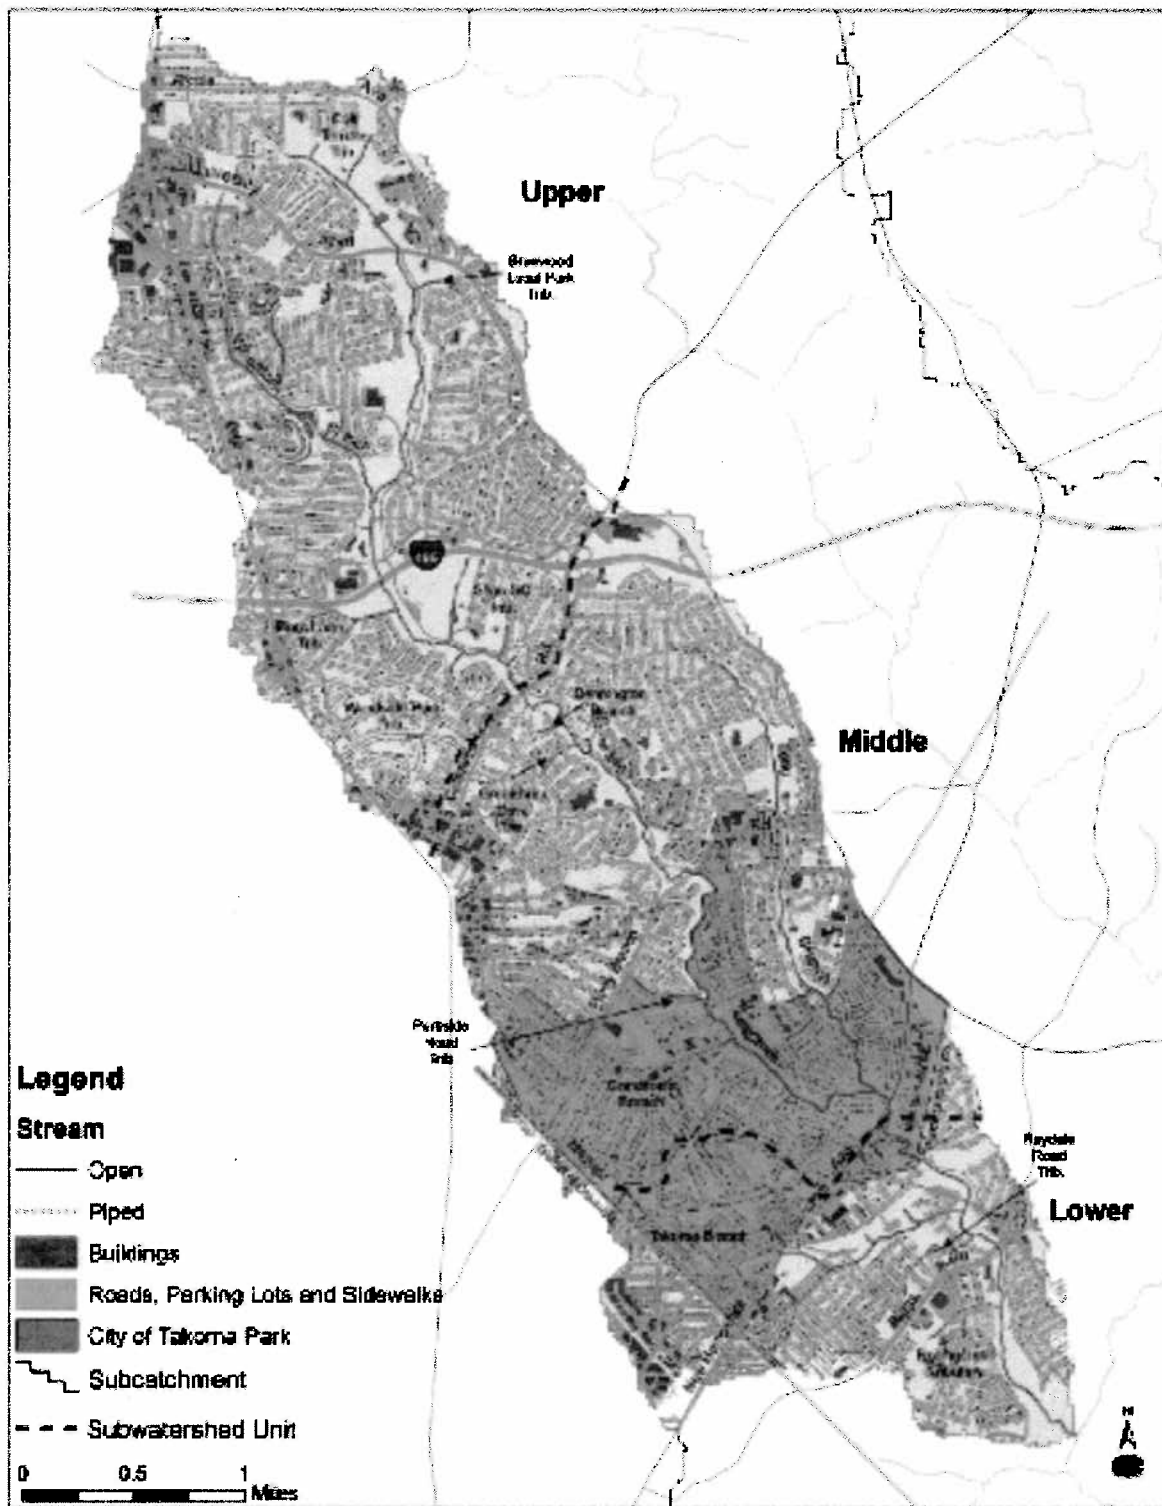
Figure 1: Takoma Park and Sligo Creek Impervious Features, Sligo Creek Sub-Watershed
